INVESTIGATION OF MICROSTRUCTURE OF ZnO VARISTORS TAKEN FROM SURGE ARRESTER COUNTERS

Keywords: surge arrester counter, ZnO varistors, microstructure of ceramics, ceramic material degradation

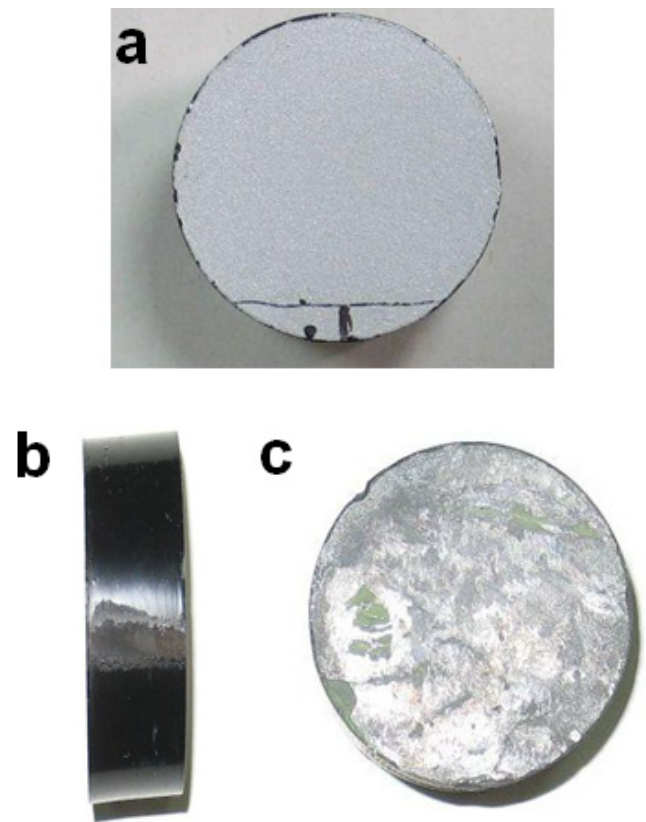
Four ZnO varistors of a leading manufacturer, coming from surge counters, were tested. A reference varistor came from a surge counter that was designed for installation in HV – 110 kV electrical network – Figure 1a. The next two varistors – marked 1 and 2 – operated in adjacent phases of the HV power grid and featured only limited traces of damage in the form of a burnt-out path on the side surface – Figure 1b. The last varistor, marked 3 – Figure 1c, was heavily smoked in the aftermath of fire. It came from a surge counter that had been installed in the 110 kV power grid phase in which, after nearly 10 years of operation, the surge arrester was destroyed.

Fig. 1. (a) – Reference varistor – coming from a surge counter that was out of operation. The area from which a block to be tested was cut off is marked on the bottom of the front surface; (b) – varistor 1 – a burnt-out path in the casing material is visible on the side surface; (c) – varistor 3 coming from a destroyed surge counter. The buildups on the front surface is noteworthy

Heavily smoked varistor 3 was removed from a destroyed surge counter. Highly advanced degradation of the material could be expected there, as a result of combined electric, thermal, and mechanical effects.

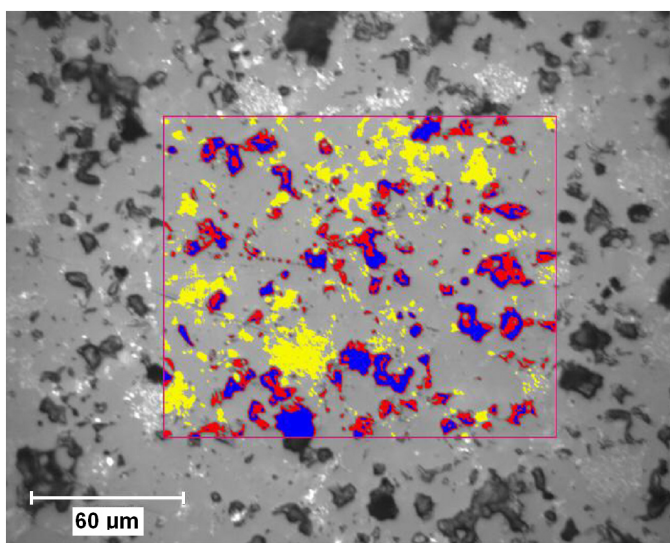
Fig. 2. Typical view of the reference varistor microstructure. A binary mask for colour was applied on the central part of the image, showing the aggregates of the light doping Bi_2O_3 phase – yellow and the spinel phase – red. The areas of chipped elements of the microstructure and scarce pores – in dark blue – cover approximately 6% of the surface. The grey background is the ZnO matrix

The observed microstructure revealed insufficient cohesion. Quite numerous spots of chipping were visible, which are the black areas with a size usually from a few to a dozen or so micrometers. It was associated with the presence of spinel phase. Individual spinel grains had an angular and polyhedral shape and a size of typically a few micrometres, which is slightly less than the ZnO matrix grains. The chipping generally covered grain groups and, together with very scarce and tiny pores, constituted on average 5.8% (from 2 to 8%) of the surface. The spinel phase was present in unexpectedly large quantities. Its non-chipped content, which remained in the microstructure, covered 12.3% (from 11 to 14%) of the surface on average. The initial spinel content in the body can be estimated at 17-18%, of which almost 1/3 was chipped during the preparation of microsections, although, a special – gentle polishing procedure was applied to samples previously flooded in epoxy resin.

The basic doping phase in varistor oxide materials is Bi_2O_3 . In the tested samples, the precipitates of bismuth oxide were distributed very heterogeneously. They were also very diverse in shape and size. The average content of Bi_2O_3 was 10.8% (from 8 to 16%). It should be emphasized that the content of Bi_2O_3 in typical varistor materials is approximately 1 to 3% [7,10]. Figure 3a shows the percentage shares of the tested phases in 10 observation fields of the reference varistor sample.

The microstructure of the material, both in the micro- and semi-macro scales, may be evaluated unfavourably, since it is insufficiently compact and homogeneous. Heterogeneity may indicate unsatisfactory mixing of powder components of varistor composite before its pressure forming and subsequent sintering. The brittleness of the spinel phase and its large clusters also suggest a non-optimal selection of sintering conditions, e.g., temperature, time, atmosphere, and their derivatives. However the reference varistor material showed the microhardness on the medium level – of $\text{HV1} = 141.6 \pm 3.6$.

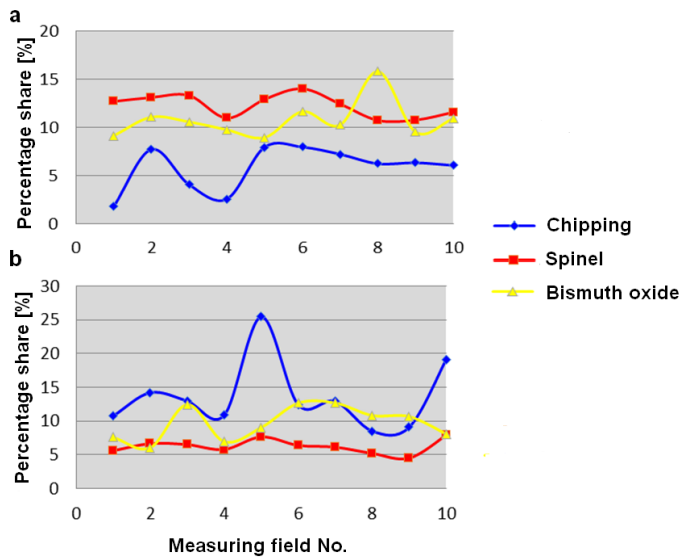
The samples from varistors 1 and 2 contained a material from the areas of direct over burning in the form of a path visible on their side surface, as well as from a slightly distant zone. Generally, the degree of the degradation of the material in both samples was similar, i.e. subcritical. However, at the same time, the microstructure parameters were significantly diversified, depending on the field of observation. This resulted from both – the insufficient homogeneity of the tested material and the degradation effects. The content of individual phases in different measuring fields changed quite widely – Figure 3b.

Only the part of the spinel phase that remained in the microstructure (non-chipped) was quite homogeneously distributed, which is similar to the reference material – Figure 3a. However, its content halved with the number of chipped microstructure elements increasing more than twice. On the other hand, the average Bi_2O_3 content, despite a significant spread, remained at the same level as in the reference sample – approximately

Fig. 3. Percentage share of individual phases in the material samples in 10 observation fields. (a) – The average values for the reference sample are as follows: crushed out elements and pores – 5.8%; non-chipped spinel – 12.3%. The initial structure contained 17-18% of the spinel phase. Bismuth oxide occupied, on average, 10.8% of the surface. (b) – The average values for varistors 1 and 2 are as follows: crushed out elements and pores – 13.6%, non-chipped spinel – 6.3%, and bismuth oxide – 10.8% of the surface

increased to a wide range of 8 to 25%-13.6% on average, as shown in Figure 3b. Under the influence of a fault current flow and thermo-mechanical stresses, the next part of the spinel phase was separated from the microstructure. Approximately 1/3 – 6.3% on average, remained out of its original quantity at the level of 17 – 18%. Moreover, the ZnO grains had a small share in the chipped elements of the microstructure – up to 2%. In some areas, peripheral microcracks around the groups of (or even individual) ZnO grains were poorly visible, but they were not chipped from the matrix. Microhardness of the material in the samples of both varistors decreased significantly, while the dispersion of this important parameter increased considerably $HV1 = 99.3 \pm 8.1$.

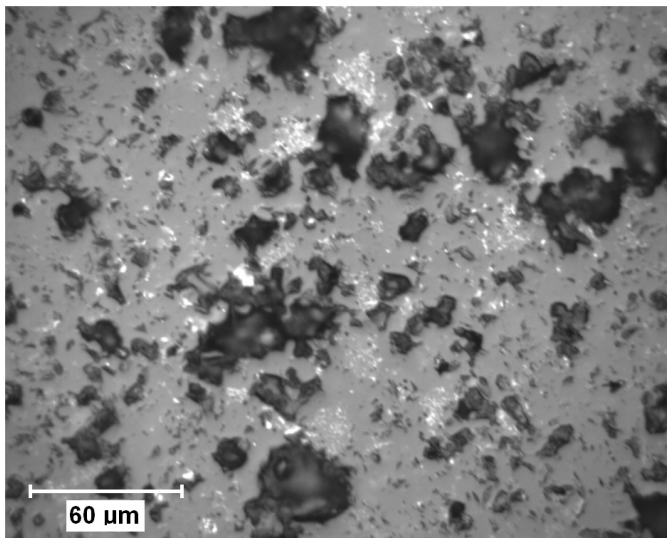
11%, on average. Therefore, it was present in relatively high quantities, but with heterogeneous distributions. Figure 4 shows a typical microstructure of Sample 1 in a zone 1 cm distant from a burnt-out path.

Fig. 4. Image of the microstructure of varistor 1 approximately 1 cm from a burnt-out path. The chipping of microstructure elements accounts for 11% of the surface

In the material of Samples 1 and 2, especially in the vicinity of the path burnt out on the cylindrical surface, the material microstructure significantly loosened, where the microstructure was not compact, cohesive, and homogeneous. The number of chippings – crushed out fragments observed in microsections,

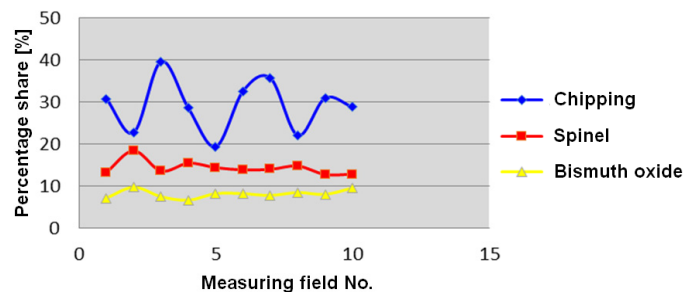
As predicted, the degree of the material degradation in the sample could be described as highly advanced subcritical, and close to critical. There appeared strong loosening and mechanical weakening of the material, the initial compactness, and cohesiveness of which were already low. At the same time, the microstructure parameters were diversified, depending on the field of observation. In particular, the fields of the areas of the crushed out elements of the material varied widely – Figure 5. This was a consequence of both – strong thermo-mechanical stresses as well as the insufficient homogeneity of the tested material.

Fig. 5. Percentage share of individual phases in the material of varistor 3 in 10 observation fields. The average values are as follows: chipping and pores – 29.1%, non-chipped spinel – 14.4%, and bismuth oxide – 8.2% of the surface

Only the part of the spinel phase that remained in the microstructure was quite homogeneously distributed, which is similar to in the material of the remaining samples – Figures 3a and 3b. However, contrary to the expectations, not only its content was not subsequently reduced, but it was even higher than in the reference material (approximately 12%). In Sample 3, the spinel phase accounted from less than 12% to approximately 19%, on average 14.4%. Therefore, only approximately 3% of the original spinel content (17-18%) was chipped. A possible explanation for this quite surprising phenomenon is a significant improvement in the binding of the spinel grains with each other and with the ZnO matrix grains as a result of melting and recrystallization effects. This could have happened in the aftermath of a sharp

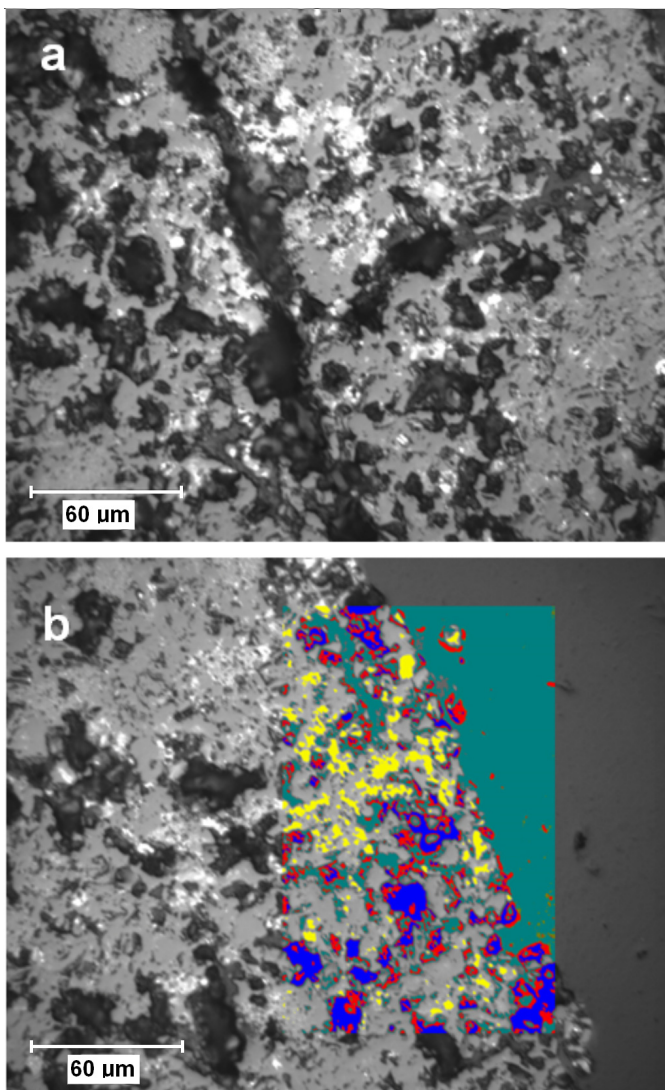
High weakening of the compactness and loosening of the material microstructure is clearly visible in Figures 6a and 6b. The number of crushed out elements observed in the microsections increased to a wide range of 19 to 40% of the surface, 29.1% on average. Thus, almost 1/3 of the material, under the influence of strong thermo-mechanical stresses, was separated from the microstructure and was chipped when polishing the microsections. However, the loss in the doping phases, Bi_2O_3 and spinel – was small – approximately 2.5% and 3%, respectively. In particular, the ZnO matrix was severely degraded. The chipped ZnO grains

Cracks were another effect of far-reaching degradation that was already critical – Figure 6a. Observation of their directions proves that they were formed and disseminated in places with large precipitates of the doping phases – Bi_2O_3 and spinel.

High temperature caused the melting of metallization (contact layer) on the front face of varistor 3. The microstructure in the boundary layer was weakened and loosened to such an extent that deep gaps were formed, through which the resin penetrated deep into the sample. The depth of the heavily cracked layer at the front surface of the varistor reached $80 \mu\text{m}$ – Figure 6b.

Fig. 6. Images of the boundary area of varistor 3. (a) – long crack initiated and propagating in the place of higher concentration of the doping phases – light Bi_2O_3 and darker spinel. (b) – the front face. The layer of metallization was melted. Grey epoxy resin in which the sample was mounted is visible on the right side. A binary mask presents the doping phases – light Bi_2O_3 aggregates – yellow, spinel – red and crushed out fragments – navy blue. The ZnO matrix is grey. Marked turquoise resin penetrates deep into the sample
