B. PAWŁOWSKI*, P. BAŁA*, T. TOKARSKI*, J. KRAWCZYK*

PREMATURE CRACKING OF DIES FOR ALUMINIUM ALLOY DIE-CASTING

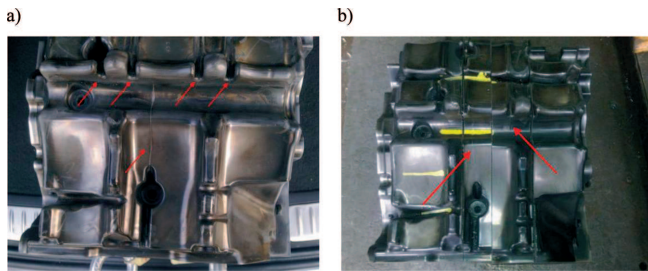
This paper investigates two damaged dies (surface parallel cracks, indicated by arrows in Fig. 3) that failed after a few thousand shots, instead of after the guaranteed one hundred thousand shots.

Fig. 3. Surface cracks of dies A (a) and B (b) that failed after a few thousand shots

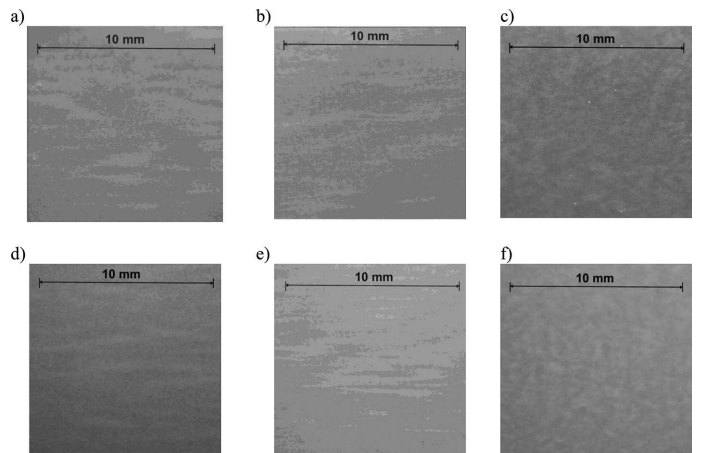
The chemical composition of the investigated steel (die A, in wt. %) was 0.32% C, 0.22% Si, 0.44% Mn, 4.71% Cr, 2.17% Mo and 0.58% V and meets the Dievar steel manufacturer requirements [11]. The microstructural banding orientation of the investigated dies can be seen in the macroscopic images of etched metallographic specimens for the XY, XZ and YZ planes (see Fig. 4), which are presented in Fig. 5. The appearance of the microstructural banding (fibrous microstructure of steel) is caused by the segregation of substitutional alloying elements during the dendritic solidification and is affected by subsequent plastic deformation. As shown in Fig. 5, for both dies, the microstructural banding direction is parallel to the X-axis of the coordinate system used, which is also the direction of surface crack propagation. A banding structure of the dies was also observed at higher magnification during the microscopic examination. The results of these observations are shown in Fig. 6. As all observed surface cracks (for both dies) were parallel to the X-axis, it is clear that such a geometrical orientation of the dies with respect to the microstructural banding promotes crack propagation. However, such microstructural banding, as presented in Fig. 5 and Fig. 6, is acceptable according to the North American Die Casting Association industry standard [12] but the banding direction does not meet the requirements of the manufacturer’s design assumptions.

Fig. 5. Macroscopic images of etched metallographic specimens, etched with 2% nital, a) die A XY plane, b) die A XZ plane, c) die A YZ plane, d) die B XY plane, e) die B XZ plane, f) die B YZ plane

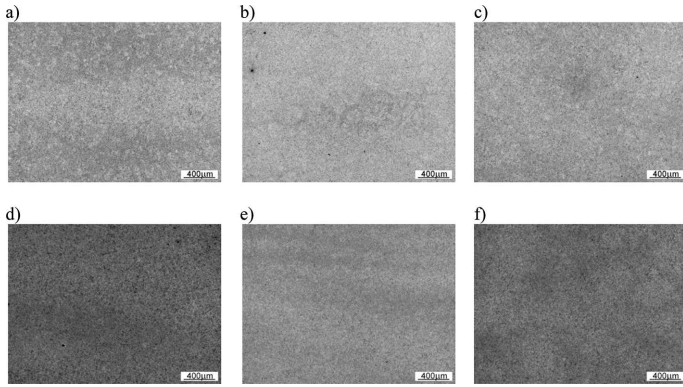
Fig. 6. Microscopic evidence of microstructural banding, etched with 2% nital, a) die A XY plane, b) die A XZ plane, c) die A YZ plane, d) die B XY plane, e) die B XZ plane, f) die B YZ plane

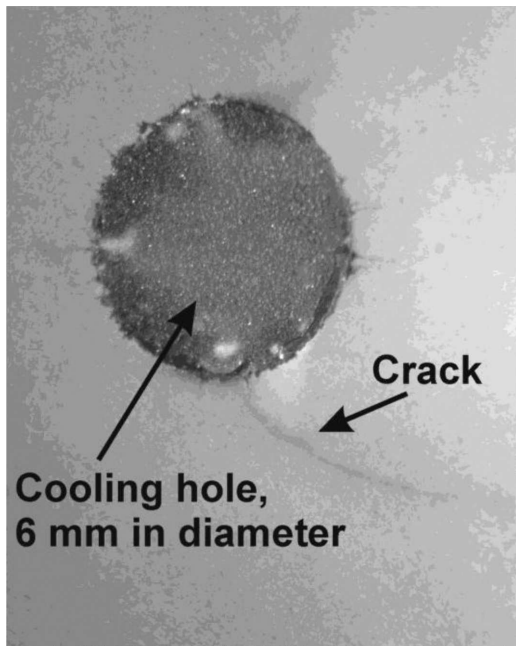
The question remains whether such an orientation could be responsible for crack nucleation on the surfaces of the dies. In the case of die A, selected for further study, it was found that nucleation of one of the cracks took place at the cooling hole edge, as shown in Fig. 7.

Fig. 7. Crack origin at the edge of cooling hole

Macroscopic observation of the cooling hole cross section (Fig. 7) revealed that around the edge of the hole, many fine cracks had started. Microscopic images of some of these are presented in Fig. 8.

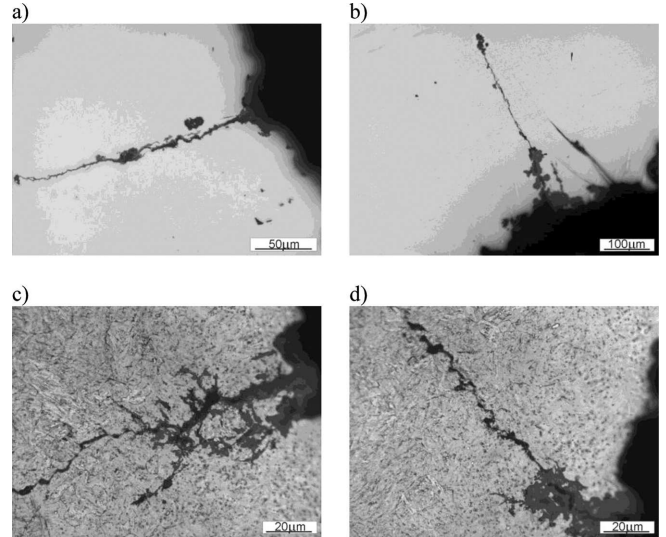
Fig. 8. Microscopic images of cracks nucleated at the edge of cooling hole: a), b) – not etched, c), d) – etched with 2% nital

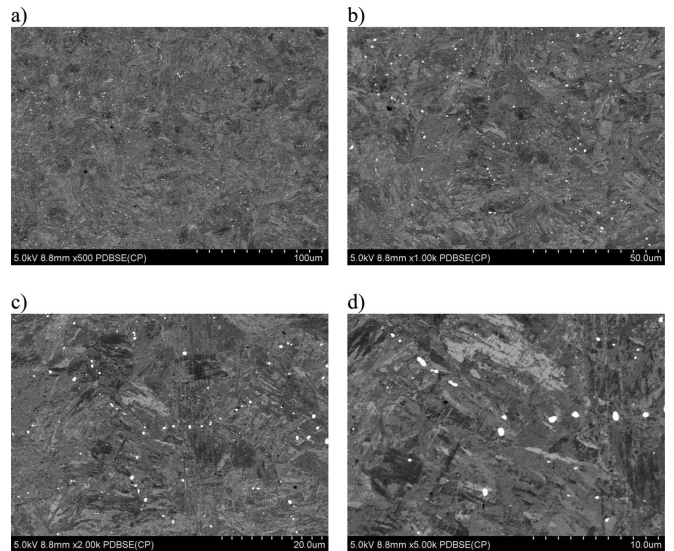
The die microstructure is typical for Dievar steel after quenching and tempering. Light microscopy studies did not confirm the presence of surface decarburisation or wear traces. It was confirmed that the surface and bulk microstructures are similar. SEM studies revealed carbides precipitated along the prior austenite grain boundaries, as shown in Fig. 9. The use of the higher accelerating voltage allowed observation of another type of carbides, precipitated inside the prior austenite grains – transgranular carbides (Fig. 10).

Fig. 9. SEM images of tempered martensite microstructure of investigated steel, accelerating voltage 5 kV

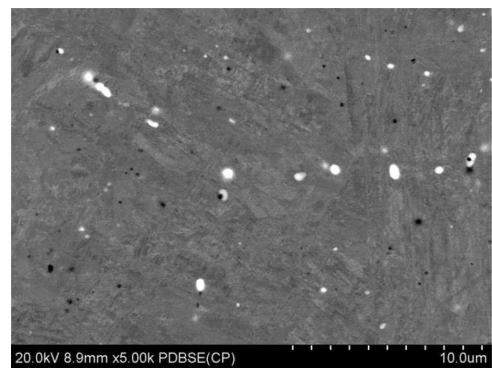
Fig. 10. SEM image of investigated microstructure presented in Fig. 9d with higher accelerating voltage 20 kV

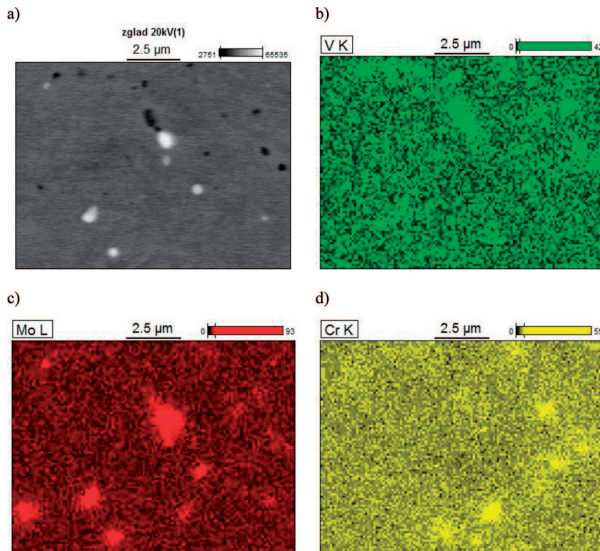
specimen), allowed the presence of vanadium carbides (MC, dark phase in Fig. 11a) and molybdenum carbides (M_2C – light phase in Fig. 11a) to be determined. The presence of the chromium rich regions shown in Fig. 11d, forced the authors to perform similar studies for the etched specimen (Fig. 12); however, in Fig. 11a, a non-etched specimen, the chromium carbides were not seen. In Fig. 12a, it can be observed that there is a large amount of coarsened chromium carbides (Fig. 12d), probably of type $M_{23}C_6$ and/or M_7C_3 .

Fig. 11. Energy dispersive element mapping performed of area shown in Fig. 10, a) microstructure, b) vanadium mapping, c) molybdenum mapping, d) chromium mapping

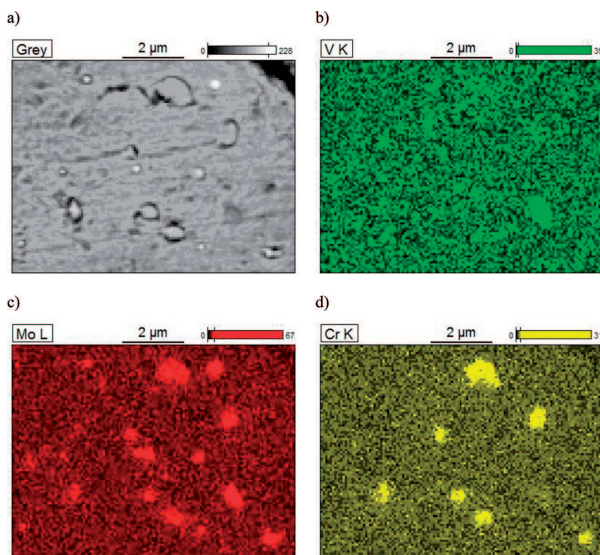
Fig. 12. Energy dispersive element mapping performed for etched specimen, a) microstructure, b) vanadium mapping, c) molybdenum mapping, d) chromium mapping

According to [13], the presence of chromium $M_{23}C_6$ and M_7C_3 carbides in Dievar steel microstructure is because of the high austenitising temperature. As stated in [13], a tempering resistance test of Dievar steel at four different heat treatments: 1020, 1060, 1100 and 1150°C, showed that an increased austenitising temperature improves the temper resistance (after hardening, all investigated materials were tempered to an equal hardness 470 ± 10 HV30).

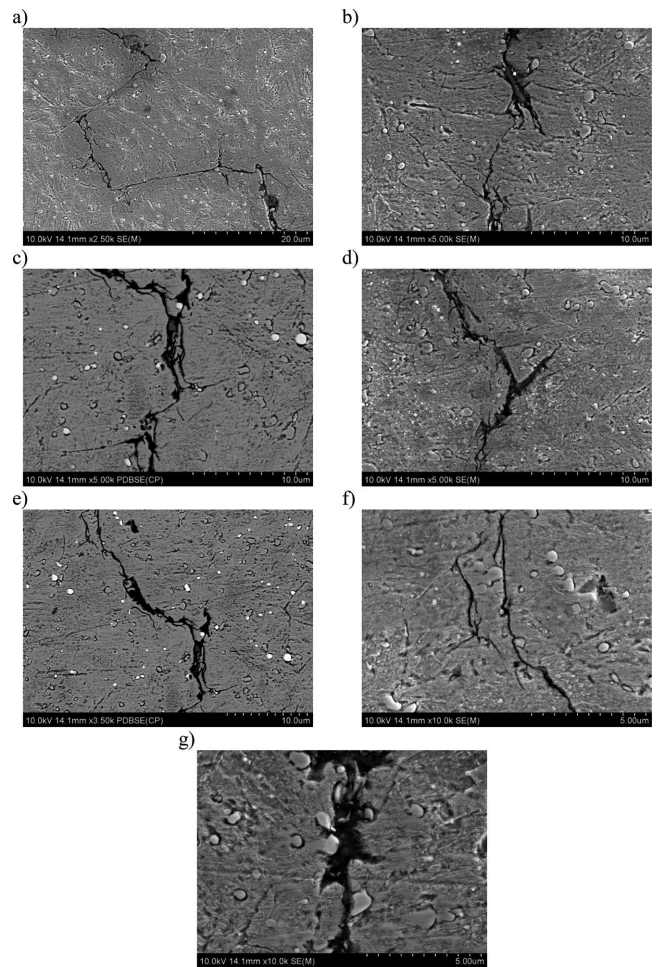
The results of microscopic examinations show that cracks presented in Fig. 7 propagate along prior austenite grain boundaries and/or tempered martensite lath boundaries, as shown in Fig. 13.

Fig. 13. SEM images of propagation path of crack presented in Fig. 7, a-g) different crack areas

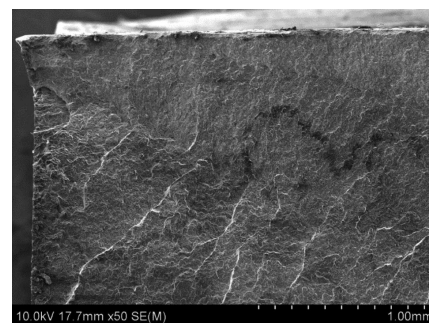
SEM observations were also made for the fracture surface at the origin of the crack presented in Fig. 7. The results of this investigation are shown in Fig. 14 and Fig. 15. As can be observed, the crack initiation occurred at the edge of the cooling hole and further crack propagation took place in stages, probably corresponding to the die-casting cycles (the so-called “shots”). Fig. 16 shows a transgranular fracture mode of the above-mentioned stages, separated by a dimple fracture area (Fig. 16a) with friction traces (Fig. 16b).

Fig. 14. SEM image of fracture surface of crack presented in Fig. 7, close to the cooling hole (crack origin)

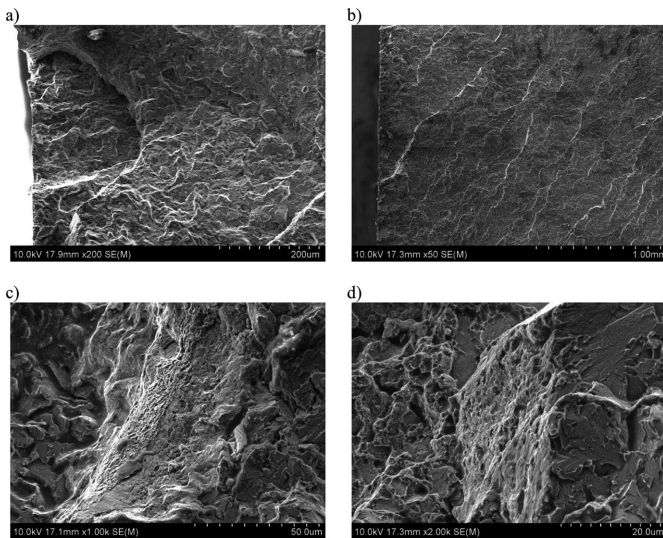
Fig. 15. SEM images of transgranular fracture mode separated by dimple fracture area, a) general view, b) crack origin, c-d) transition region

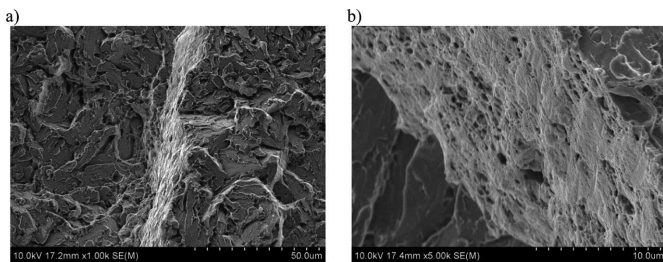
Fig. 16. SEM images of fracture surface a) brittle crack propagation stages, b) dimple fracture transition area

The results of SEM studies (brittle fracture mode) suggest that the fracture toughness of the investigated dies might be not as high as guaranteed by the producer (impact energy approximately 27 J at room temperature for the required Rockwell hardness 47 HRC) after quenching and tempering [11].
