## HYDROGEN EMBRITTLEMENT OF WELDED JOINT MADE OF SUPERMARTENSITIC STAINLESS STEEL IN ENVIRONMENT CONTAINING SULFANE

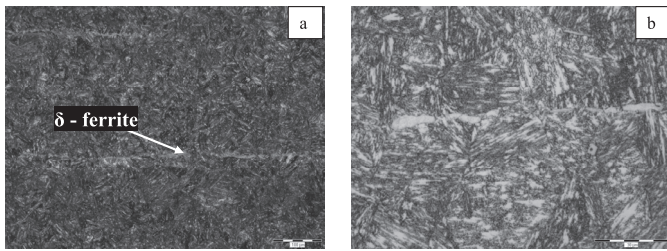
Structural analysis of the samples was made with use of light microscope ZEISS NEOPHOT 32. Unfortunately certain areas of martensitic structure in basic material contained  $\delta$ -ferrite, which degrades properties of supermartensitic steels. Microstructure of basic material is shown in the Fig 1. Microstructure of the welded joint is shown in the Fig. 2. Weld metal (WM) has a coarse-grained martensitic structure. Heat affected zone (HAZ) has fine grained martensitic structure without coarse grained area at the fusion line.

Fig. 1. Microstructure of basic material

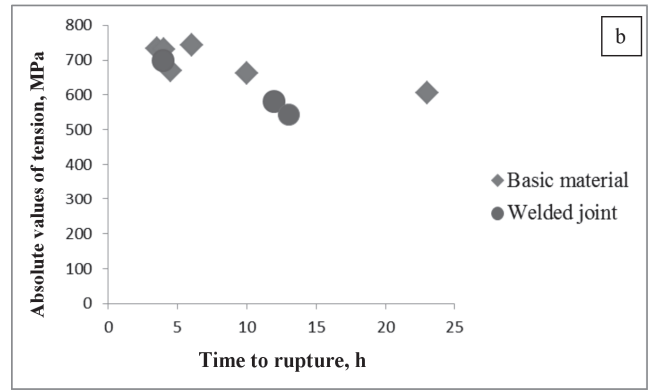
It is obvious from the Fig. 3 a, b that all the testing samples were fractured and in a very short time interval. It is therefore possible to state that the samples were under the given testing conditions insufficiently resistant to SSC. An example of cracking in the basic material, which was probably caused by superposing effect of hydrogen induced cracking (HIC) and SSC is shown in the Fig. 4.

Fig. 3 Results of SSC tests

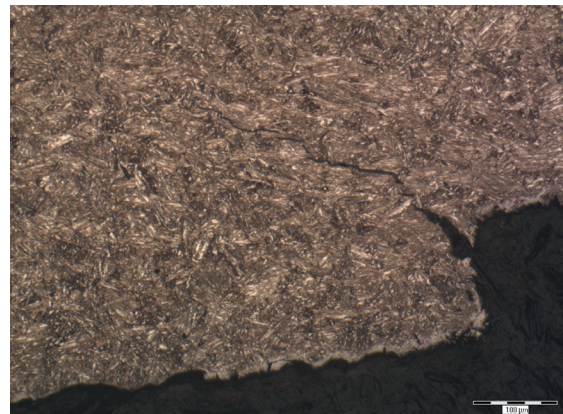
Fig. 4. Example of cracking in basic material (superposition of HIC and SSC)

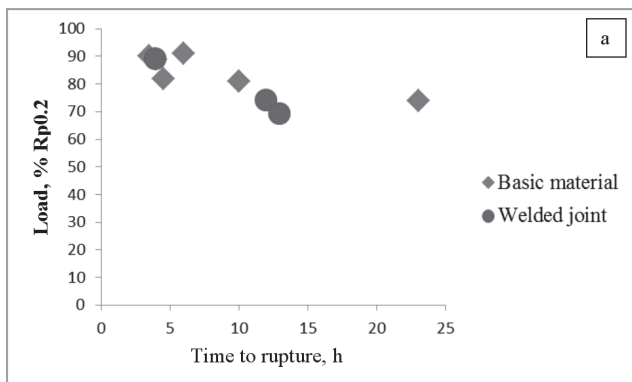
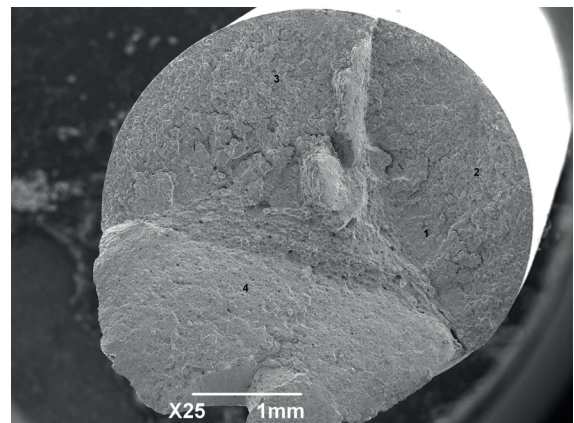
Fracture areas of samples were subjected to fracture analysis on scanning electron microscope JSM 6490. Overall appearance of fracture areas was similar both in basic material and in welded joint. It was always possible to discern the area of slow propagation of crack and area of final rupture, see the Figs 5 and 7.

Fig. 5. Overall appearance of the fracture area of basic material, load 82 %  $R_{p0.2}$ , time to rupture 4.4 h

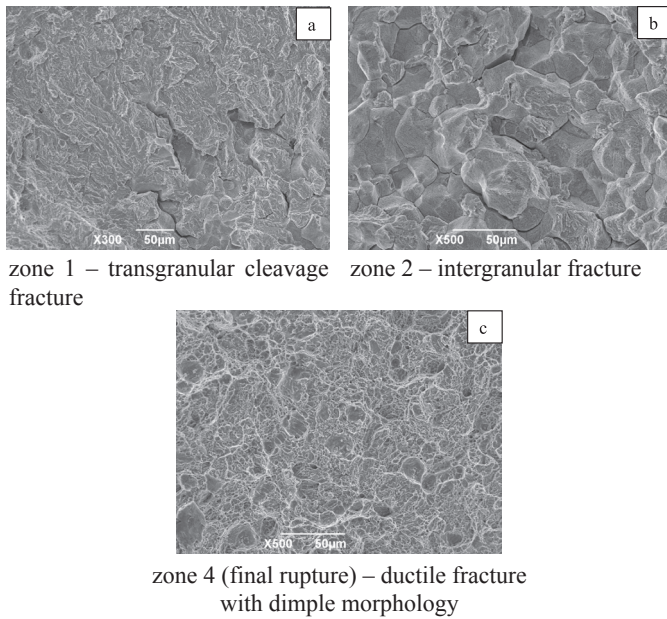
Fracture areas of basic material had zones with different morphology. Characteristic photos are shown in the Fig. 6 a, b, c.

Fig. 6. Fracture – basic material, load 82 %  $R_{p0.2}$ , time to rupture 4.4 h

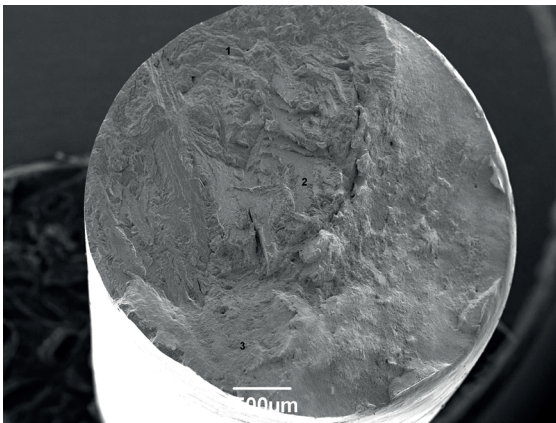
Fig. 7. Overall appearance of the fracture area of welded joint, load 74 %  $R_{p0.2}$ , time to rupture 12.10 h

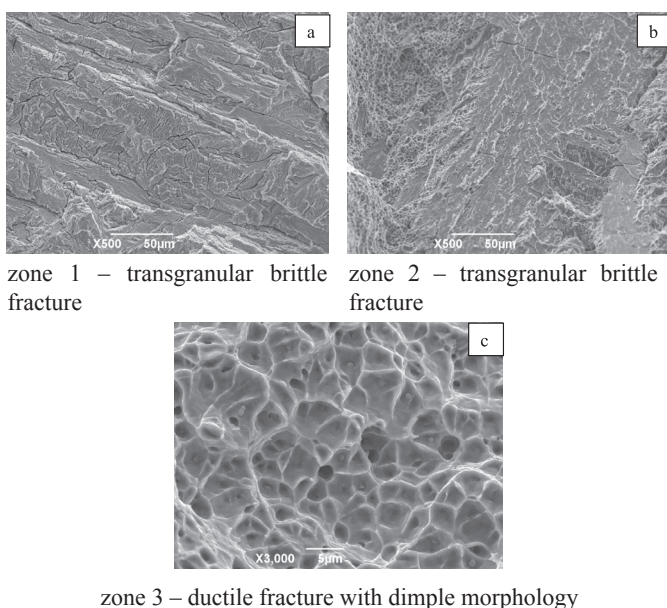
Fracture areas of the welded joint were characterised by the zones of transgranular brittle fracture Fig. 8 a, b and some areas of ductile fracture with characteristic dimple morphology were observed as well Fig. 8c.

Fig. 8. Fracture area - welded joint, load 74 %  $R_{p0.2}$ , time to rupture 12.10 h
