EFFECTIVE METHODS FOR THE DIAGNOSIS OF VEHICLES ROLLING BEARINGS WEAR AND DAMAGES

The article presents methods of diagnosis of rolling bearings; especially those are used in diagnostics of bearings in wheels vehicles. Active experiments were performed on three bearings built in driving wheels of different vehicles. In diagnosis were used selected methods, including the method of metallographic examination.

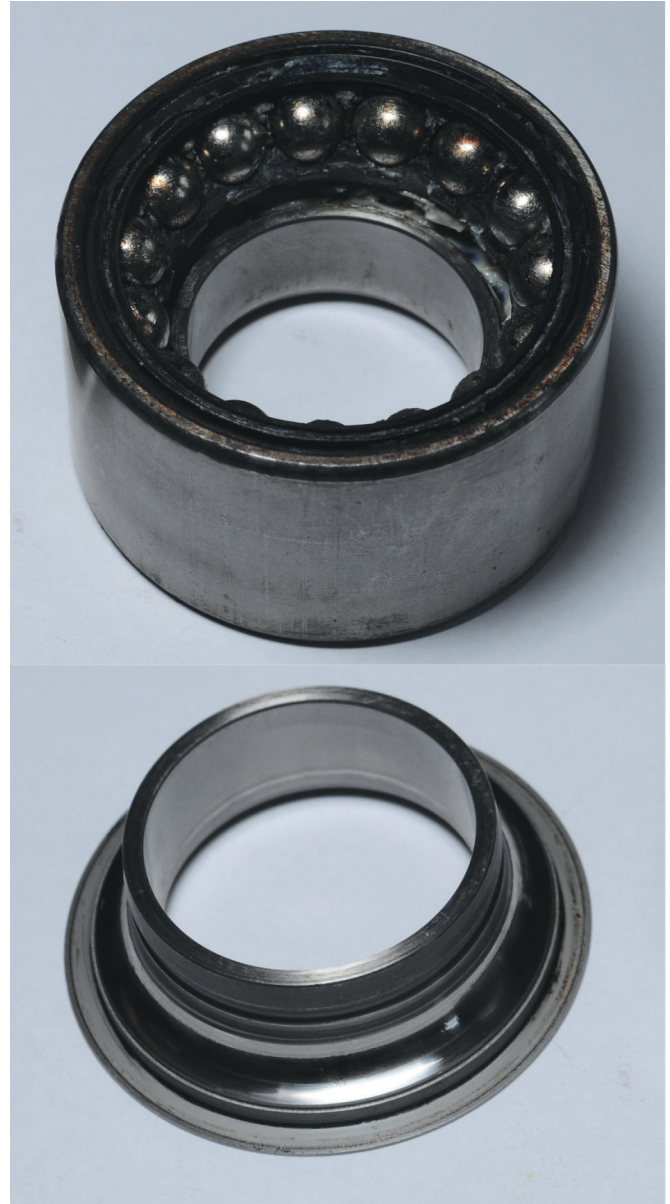
Fig. 3. Bearing VKBA 6831 with inside track

As the third, was tested the bearing of Toyota Avenis. It was produced also by companies SKF and is marked as VKBA 6831. It is shown on figure 3.
