A. ZIEWIEC*, A. ZIELIŃSKA-LIPIEC*, E. TASAK*

MICROSTRUCTURE OF WELDED JOINTS OF X5CrNiCuNb16-4 (17-4 PH) MARTENSITIC STAINLEES STEEL AFTER HEAT TREATMENT

The paper presents results of microstructure (LM, TEM) investigation and hardness measurements of welded joints in martensitic precipitation hardened stainless steel containing copper, subjected to heat treatment. For the aging temperature up to 540°C even for the very long times, the microstructure of the welded joints is similar to this one at lower temperature aging. After aging at 620°C a distinct change of the microstructure was observed. Non-equilibrium solidification conditions of the weld metal, segregation and the diffusion of copper and the elements stabilizing the austenite cause the occurrence of the reverse transformation of the martensite into austenite as fast as just 1 hour at 620°C. TEM investigations revealed the differences in dispersion of hardening copper precipitates after aging at temperature 620°C for 1 and 4 hours.

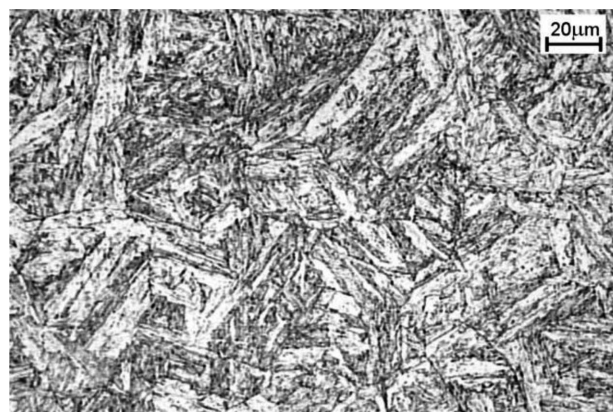
Fig. 1. Microstructure of the base metal after welding; martensitic microstructure

The microstructure of base metal used for the welding consists on tempered martensite with fine carbides precipitates inside the martensite laths and at their boundaries (Fig. 1).

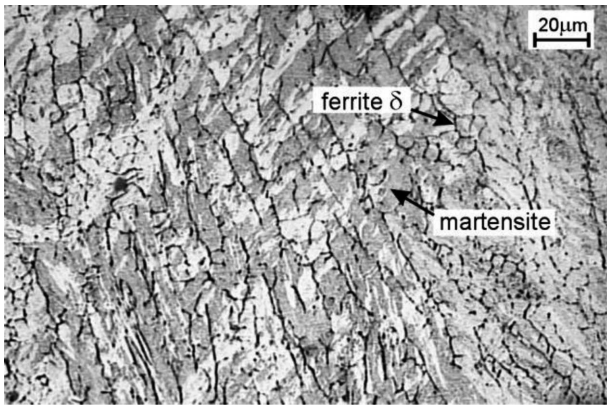
Fig. 2. Weld microstructure without heat treatment

The solidification mode of the 17-4PH weld is ferritic, therefore during the welding and the subsequent cooling the sequence of the phase transformations in the weld is the following:

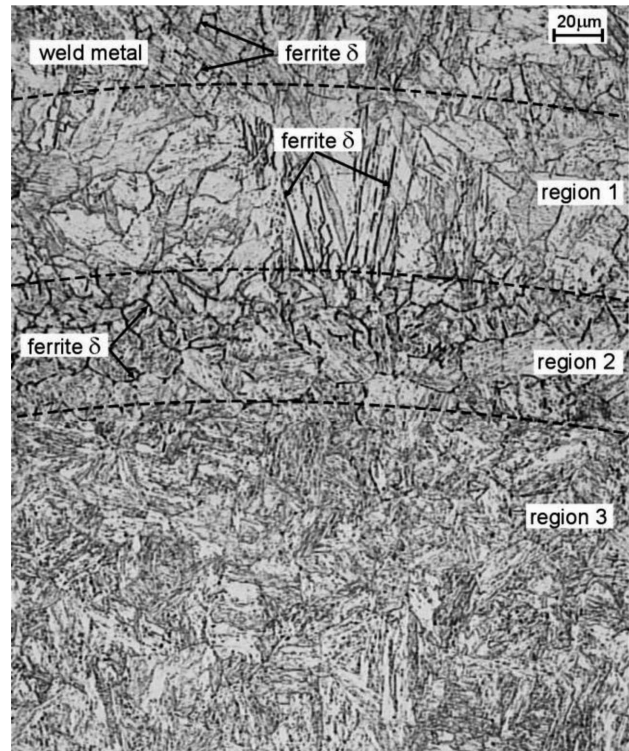
Fig. 4. Microstructure near the fusion line and the high-temperature regions of the HAZ from the place marked "A" in Fig. 3

The light microscopy study shows the evidence that there are the phase transformations in the HAZ during the welding of the 17-4PH steel. The four areas can be distinguished in the HAZ (Fig. 3). Directly at the fusion line a coarse grained δ ferrite can be observed. The δ ferrite transforms into austenite during cooling and below the M_s temperature turns into martensite (Fig. 4). Finally, some remnants of non-transformed δ ferrite may be found in the microstructure. At lower temperatures the area that was heated during welding to the range of γ austenite + δ ferrite can be found (region 2). The δ ferrite is located at the grain boundaries and during the subsequent cooling sequence will not transform into austenite and in the martensite. The martensite with a network of intergranular δ ferrite can be visible on Fig. 4. Below 1200°C there is an area which is heated during welding to the temperature range of austenite. After cooling the martensite can be observed in the microstructure (region 3). The region heated up to the temperature range Ac_1 - Ac_3 consists of the austenite coexisting with martensite, and after cooling transforms into the newly formed martensite and the tempered martensite. Figure 5 shows the example of the region heated up to the temperature slightly higher than Ac_1 . The grains of the newly formed martensite (difficult for etching) martensite within the tempered martensite are observed.

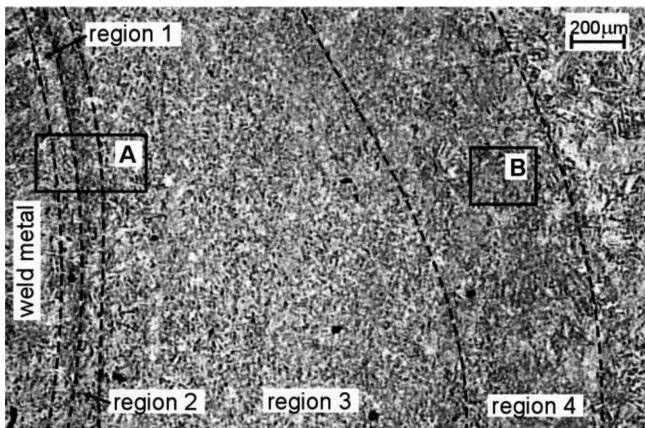
Fig. 3. HAZ microstructure with the characteristic regions marked with dashed lines

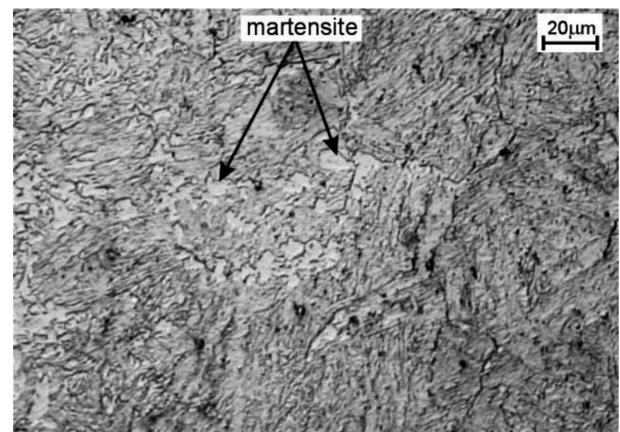
Fig. 5. Microstructure of the region no 4 from the place marked "B" on Fig. 3 heated to the temperature slightly higher than Ac_1 . The "fresh" martensite within the tempered martensite

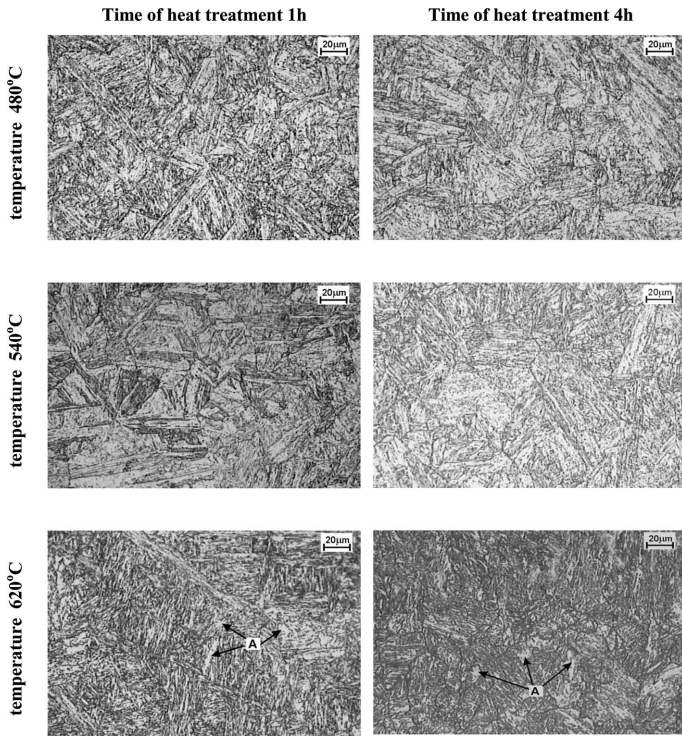
Fig. 6. Base metal microstructure after heat treatment. The bright regions visible between the plater of austenite (marked by arrows and capital letter “A”)

Microstructure of the base metal after aging at 480°C and 540°C (Fig. 6) does not show any distinct differences from that one in the as-welded state. However, only a lightly stronger etching of the grain boundaries is observed. For of the sample aged at 620°C for 1h and 4h the stronger etching is visible. This is most probably related with precipitation of the hardening phases. The dilatometric studies shown that the Ac_{1s} onset temperature is 614°C (Fig. 7). The heat treatment temperature at 620°C is higher than the temperature of austenite formation and during the subsequent cooling the austenite may transform into martensite. In the case of high stability of austenite, the γ - α' transformation will not occur.

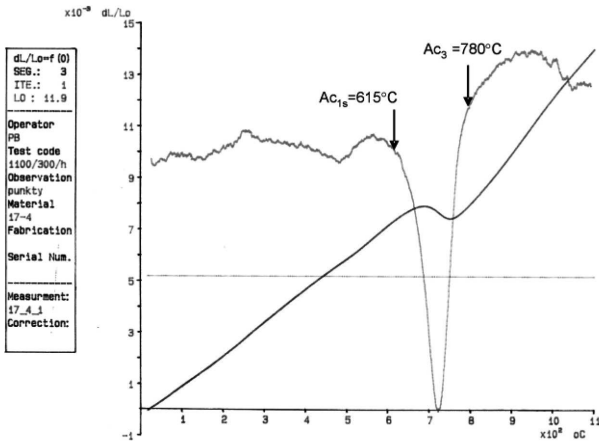
Fig. 7. Dilatometric heating curve (heating rate 0.1°C/s) and differential curve with the temperature values of the critical points A_{c1} and A_{c3}

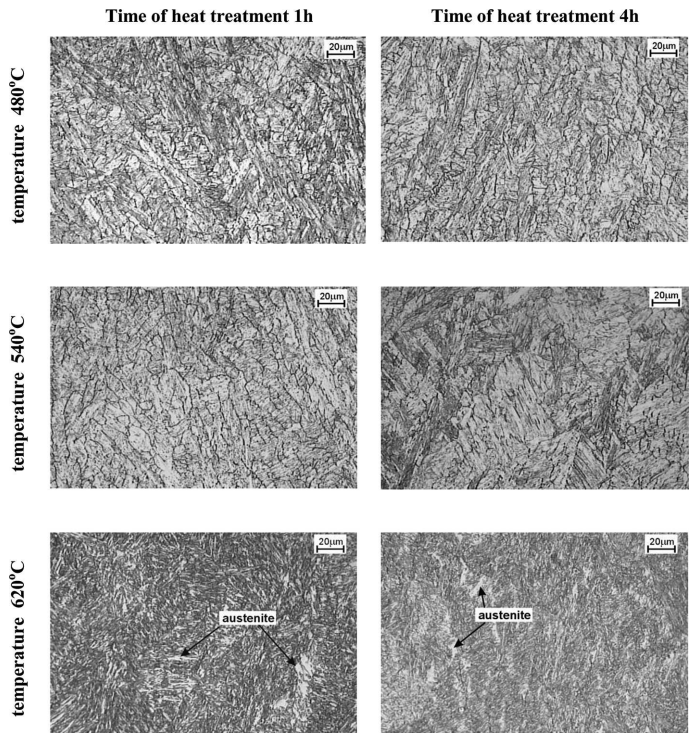
Fig. 8. Weld metal microstructure after heat treatment

Aging up to 540°C does not affect significantly the microstructure of the weld metal observed by light microscopy (Fig. 8). The only effect is a slightly more pronounced etching due to the precipitation of carbides and hardening phases. Starting from the aging temperature of 620°C the microstructural changes are observed. In areas where the segregation is observed at the grain boundaries and cell boundaries where A_{c1} temperature is lower the austenite is formed. The austenite transforms into martensite after cooling. In the case of high stability of austenite, it cannot undergo phase transformation, similarly to base material.

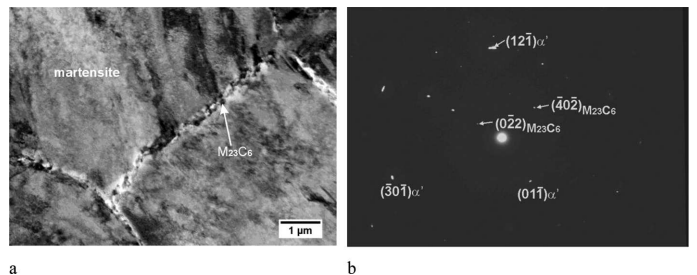
Fig. 9. Weld microstructure after annealing 620°C / 1 hour, b) electron diffraction pattern, $[\bar{1}22]M_{23}C_6$, $[\bar{1}23]_{\alpha}$

microstructure of the lath martensite with $M_{32}C_6$ precipitates at the grain boundaries (Fig. 9). No precipitates within crystallites are observed. This can be related with an extensive segregation of chromium occurring upon the solidification treatment. Such segregation promotes the nucleation of precipitates on boundaries of the primary crystallites. The small amounts of the δ ferrite (Fig. 10) are observed near the boundaries of the crystallites. The tin film of the retained austenite occurs on the boundaries of lath martensite (Fig. 11). In the regions where segregation of the chemical elements occurred, a stable austenite is formed as a result of $\alpha \rightarrow \gamma$ transformation. The aging process proceeds in martensite. A numerous nanoparticles of Cu-rich fcc precipitates are observed (Fig. 12a). Prolongation of the time of annealing up to 4 hours at 620°C leads to further progress of the aging process. The fcc Cu-rich precipitates are growing (Fig. 12b). The $M_{23}C_6$ precipitates and a few remnants of δ ferrite are still observed at the crystallite boundaries. The austenite, stable down to the room temperature, formed during $\alpha \rightarrow \gamma$ transformation exhibits a lower dislocation density (Fig. 13). The increase of copper solubility in the austenite causes dissolution of the fcc-Cu precipitates and stabilization of austenite.

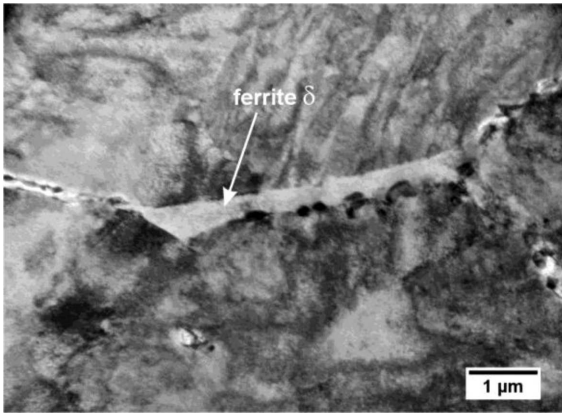
Fig. 10. Weld microstructure after annealing at 620°C for 1 hour. The remnants of δ ferrite are indicated by arrow

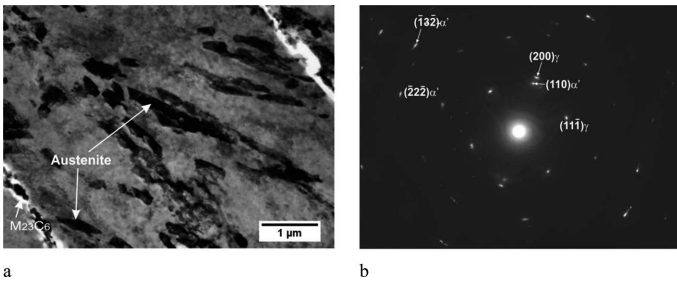
Fig. 11. Retained austenite in the middle of the grains of the weld of 17-4PH steel after annealing at 620°C for 1 hour; a) bright field, b) electron diffraction pattern $[011]_{\gamma}$, $[\bar{1}12]_{\alpha}$, $[011] M_{23}C_6$

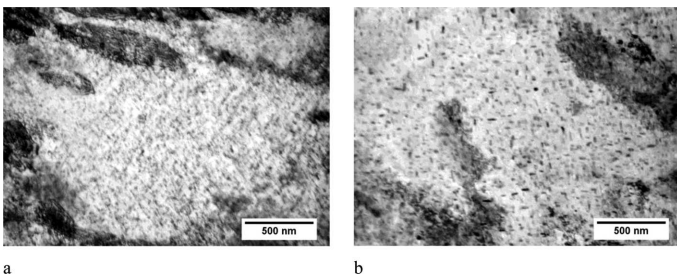
Fig. 12. a) Fine highly dispersed fcc-Cu precipitates inside the laths of martensite after annealing at 620°C for 1 hour, b) Larger fcc-Cu precipitates inside the laths of martensite after annealing at 620°C for 4 hour

Transmission electron microscopy investigations showed that the aging of the welds with the martensitic microstructure at 620°C causes an intensive precipitation of the strengthening copper-rich particles. The size of the particles increases with the aging time. There are $M_{23}C_6$ carbides precipitate on the boundaries of the primary crystallites what is accompanied by

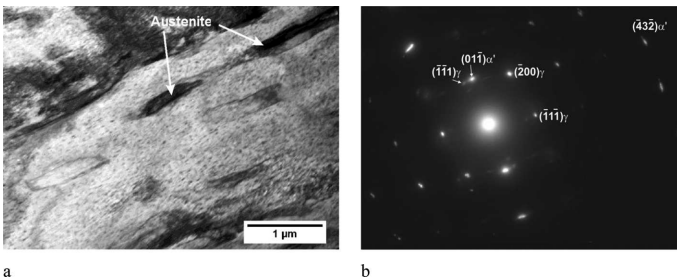
Fig. 13. Retained austenite in the of 17-4PH steel after annealing at 620°C for 4 hour; a) bright field, b) electron diffraction pattern $[011]_{\gamma}$, $[\bar{1}44]_{\alpha}$

the presence of the thin film of austenite. The retained austenite occurs inside the grains and at the grain boundaries of martensite laths. The increase of the aging time up to 4 hours results in the formation of the austenite due to the $\alpha \rightarrow \gamma$ transformation. Such austenite is stable after cooling down to the ambient temperature.

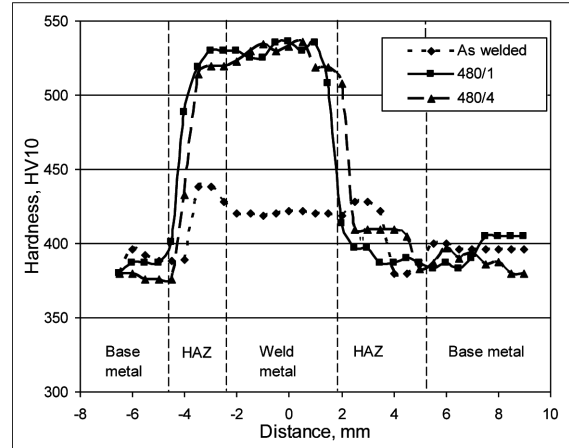
Fig. 14. Distribution of hardness vs. distance after welding and aging 480°C /1h, 480°C/4h

The results of hardness measurements are presented on Figs. 14-16. The hardness profile for the examined samples shows that after aging at 480°C hardness of the weld is the

largest. The significant drop of hardness at 540°C is observed in the weld and HAZ. The weld metal did not changed its hardness in comparison with the sample heat treated at 480°C. The overaging at 620°C caused significant decrease of hardness in the weld below 400 HV10, while the corresponding value in the weld metal decreased to ca. 350 HV10.

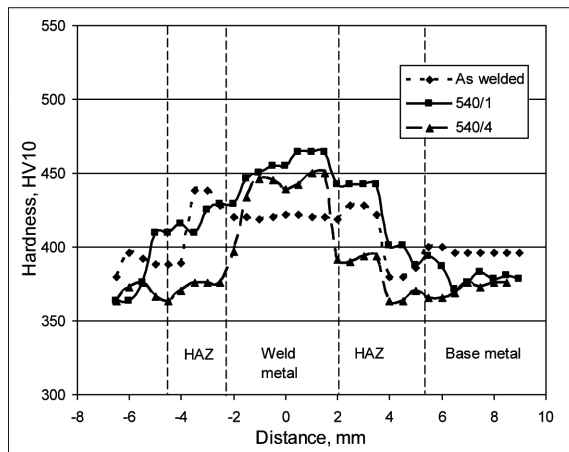
Fig. 15. Distribution of hardness vs. distance after welding and aging 540°C/1h, 540°C/4h

The changes in hardness depend on the temperature and time of tempering. At the temperature 480°C the highly dispersive coherent precipitations of copper are strongly contributing to hardening of the alloy. This influences the high hardness at this temperature. Due to the fact that the drop of hardness at 540°C was small, it can be concluded that the coherence of the hardening precipitates at this temperature is still preserved. A distinct decrease of hardness after treatment at 620°C is caused by overaging of the martensite and formation of austenite. After the prolonged overaging at this temperature, copper diffuses to the grain boundaries and boundaries of the martensite laths. This is the reason of the depletion of martensite in copper and other chemical elements stabilizing the austenite [4]. Furthermore, the character of weld solidification is attributed with strong segregation of the elements that promote formation of austenite at grain boundaries. This causes that these regions are enriched in the elements decreasing the A_{c1} temperature. Depending on the stability, the austenite formed during the

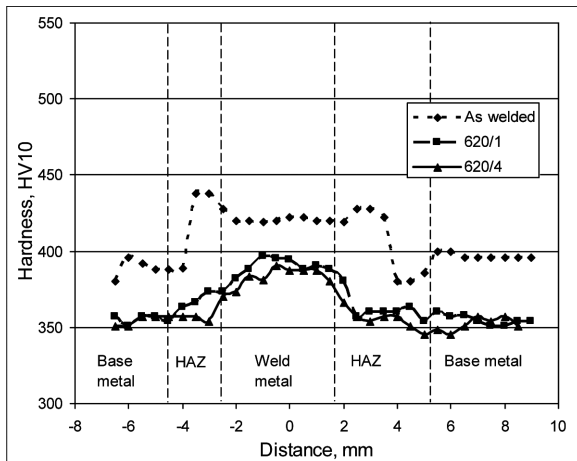
Fig. 16. Distribution of hardness vs. distance after welding and aging 620°C/1h, 620°C/4h
