## HYDROGEN EMBRITTLEMENT OF WELDED JOINT MADE OF SUPERMARTENSITIC STAINLESS STEEL IN ENVIRONMENT CONTAINING SULFANE

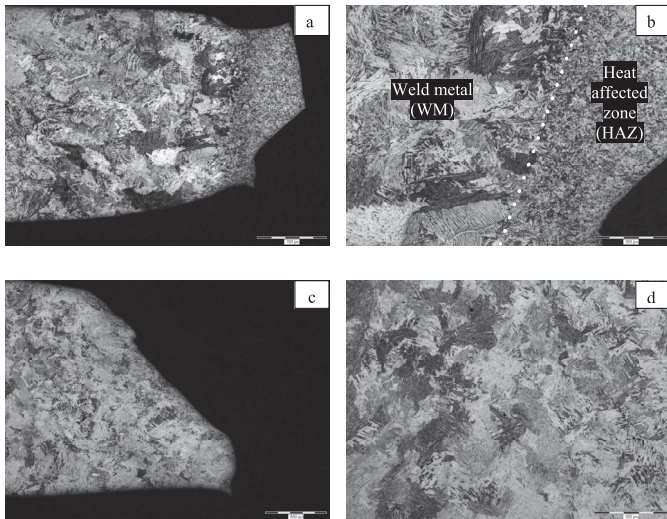
Structural analysis of the samples was made with use of light microscope ZEISS NEOPHOT 32. Unfortunately certain areas of martensitic structure in basic material contained  $\delta$ -ferrite, which degrades properties of supermartensitic steels. Microstructure of basic material is shown in the Fig 1. Microstructure of the welded joint is shown in the Fig. 2. Weld metal (WM) has a coarse-grained martensitic structure. Heat affected zone (HAZ) has fine grained martensitic structure without coarse grained area at the fusion line.

Fig. 2. Microstructure of welded joint
