EXPERIMENTAL DETERMINATION OF THE SYNERGISTIC COMPONENTS OF TRIBOCORROSIVE WEAR OF Ni-Cu-Mo-AUSFERRITIC DUCTILE IRON

The paper presents results of a two-stage study on the tribocorrosive wear of ADI alloy cast iron containing Ni and Cu. In the first stage of the wear tests with use test rig type pin-on-plate, there were determined the parameters of the process of tribocorrosion of the ADI cast iron in 3.5% NaCl solution. In the second stage, the tests were carried out on a test rig simulating real operating conditions of chain wheels used in armoured face conveyors. The purpose of this study was to demonstrate the impact of the combined action of corrosive agents (water and NaCl) and quartz abrasive on the wear of the wheels tested. As part of the test, the abrasive wear in the presence of the abrasive material alone and in the presence of a mixture of the abrasive material, water and NaCl was determined. The microstructure and the hardness of the surface layer as a function of the distance from the surface were also determined. During the study it has been found that regardless of the type of test there is a synergy between the effects of corrosion and friction which led to an in

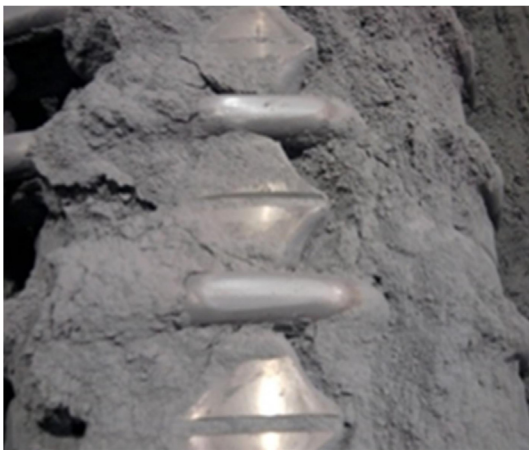
Fig. 4. A view of the chain wheels during the wear tests in the presence of the quartz abrasive

The first variant of wear was realized by filling the box of the test rig with dry abrasive (Fig. 4), which ensured its presence in the area of mating between the chain wheel and the chain. The second variant of wear was realized by filling the box of the test rig with quartz abrasive and adding appropriate quantity of 3.5% salt solution in water.

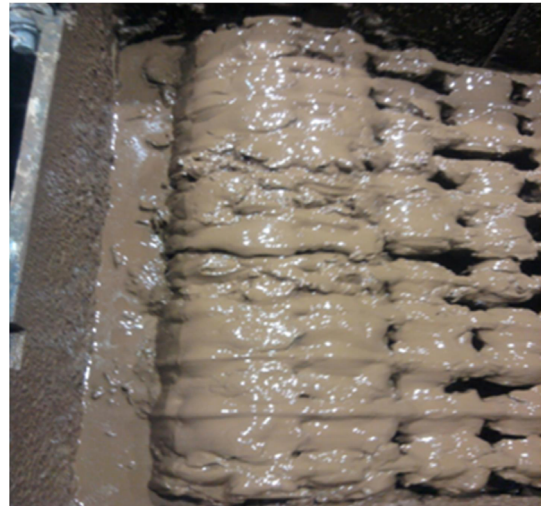
Fig. 5. A view of the test rig for wear tests filled with the abrasive mixture composed of quartz sand and water – at the initial stage of the tribocorrosive wear tests

The initial share of the corrosive agent in the abrasive was determined by dosing 900 kg of washed quartz sand with the original grain size of 1 mm, and then adding 100 litres of salt solution, which ensured its 10% share during the wear tests. In the course of the operation of the test rig, an accelerated evaporation of water from the abrasive-corrosive mixture took place due to the friction of chain wheels and the chain against the abrasive. In order to prevent the possibility of operating the test rig with dried abrasive, 20 litres of water were added to the mixture every 2 hours, which restored its initial consistency (Fig. 5). However, at the end of the wear tests with a hydrated mixture of sand, a qualitative change in the consistency of this mixture was observed, which was caused by the fact that oxide layers being removed were present in it (Fig. 6).

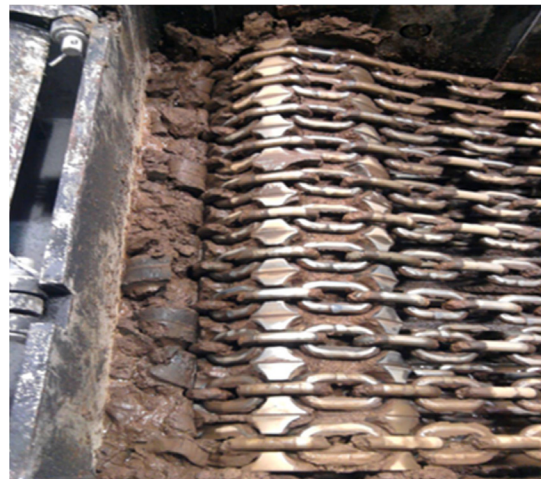
Fig. 6. A view of the test rig for wear tests filled with the abrasive mixture composed of quartz sand and water – at the final stage of the tribocorrosive wear tests

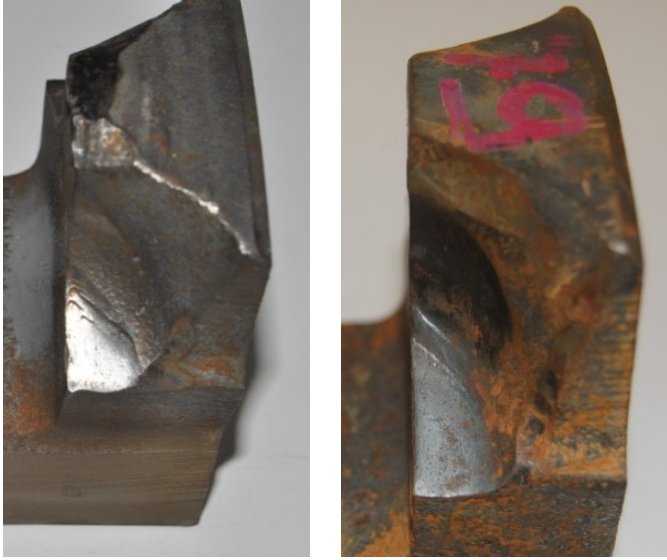
Fig. 11. Traces of abrasions on tooth surfaces of the test chain wheels made of ADI_360; A – the variant of wear involving quartz abrasive, B – the variant of wear involving quartz abrasive and salt solution

During 10 hours of operation of the test rig, the quartz sand grains were completely crushed. Despite a decrease in the size of the abrasive grains, an intensive abrasive wear was still observed. Due to the presence of water, a passivated oxygen layer was formed on the newly exposed surface by abrasive grains. It was easily removed by the diminished abrasive grains. Damage to the area of mating between the wheel and the chain had the form of shallow abrasions (Fig. 11).
