SELECTED CYCLIC CORROSION TESTS IN AUTOMOTIVE INDUSTRY

Keywords: corrosion test, automotive, aluminum, heat exchanger, corrosion products

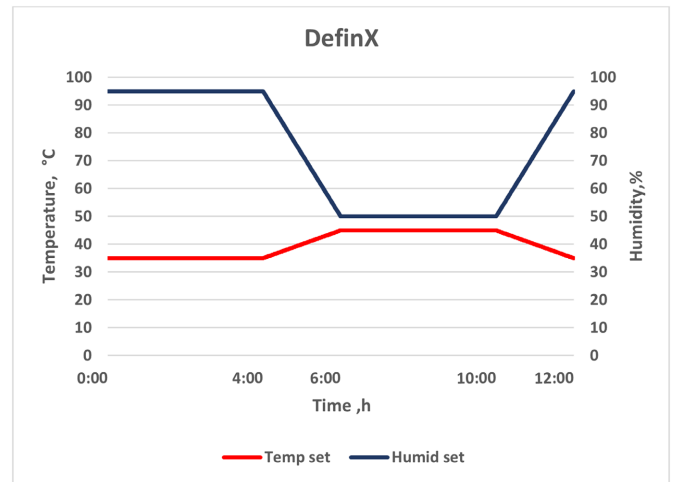
Fig. 3. DeFinX test cycle [2]

The test is performed in stages. In the first phase, samples – 10×20 cm fragment is cut out from whole exchanger. Then they are immersed in a cleaning agent with a pH above 9. In the next stage the sample is placed in a climatic or corrosion chamber, which has the ability to regulate humidity and temperature according to Fig. 3. The sample is sprayed with a mixture of water and salt. Test duration is 6 weeks.

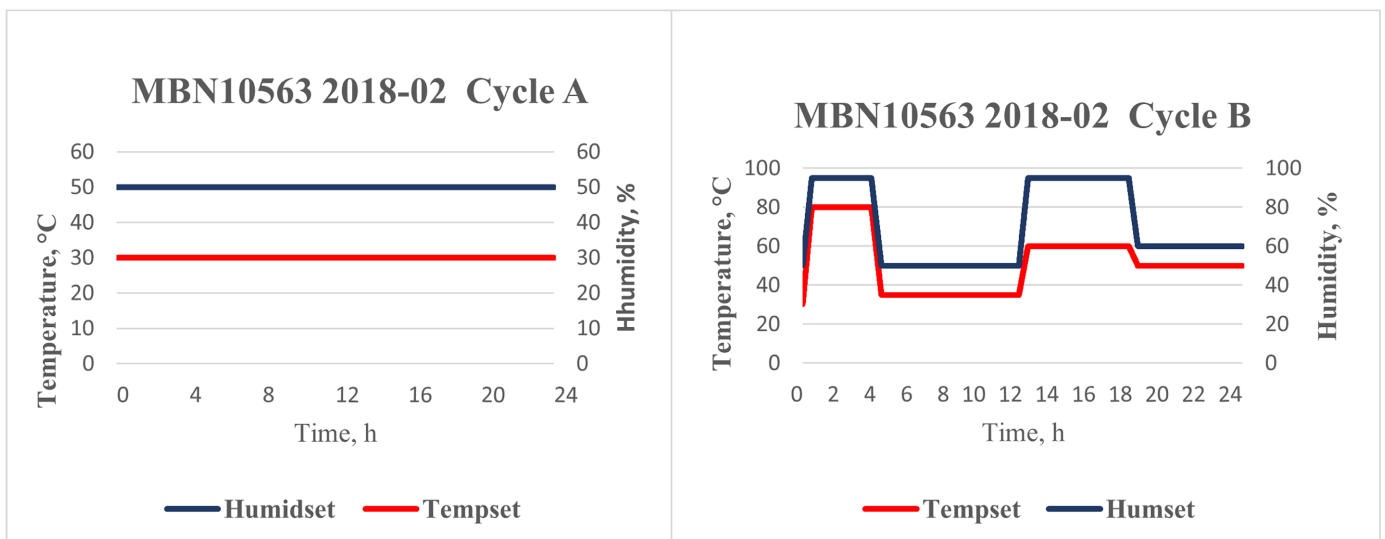
Fig. 4. MBN10563 test cycles [2]

ity is changed in within the given values. Moreover, additional flexibility was introduced in the form of a “immersion” cycle of samples, which is an alternative to the typical spraying in a corrosion chamber [10]. The solution itself is not new and is based on the ISO 9227 – CASS standard, which has been used since the 1970s. As a result of using the above-mentioned solution, a corrosion catalyst in the form of Cu ions appears in the test, which largely promotes the local corrosion on the surface of the materials tested. It is directly related with interaction of copper ions with alumina surface . The cycle diagram is presented on the Figure 4. Test duration is 6 weeks.

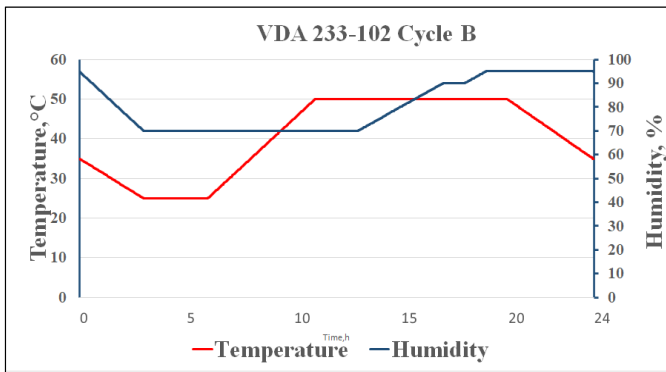
Fig. 5. VDA 233-102 test cycles [9]

into consideration a temperature range it such be noted that the test includes temperatures below zero as well. Test consists of 3 sub-cycles (A, B, C) with different courses. It was presented on Figure 5 below. The test scheme is specified as a combination of B-A-C-A-B-B-A cycles. Cycles A and B are about change of temperature in the range of 35-50°C and humidity on the level of 50-98%. The difference between A, B and C cycle is related to the introduction of temperature range to -15°C in the C cycle. Such attitude is not often found in corrosion tests.

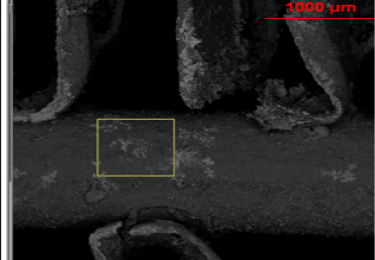
TABLE 4

from the market as well. The market samples were taken from regularly used car after end of its technical life. The results of SEM analysis (Table 4) shown that the chemical compositions of used solutions were significantly influenced on the tests results

The presented tests shown a significant diversity of chemical composition of corrosion products. Most of the observed elements are components of the used solutions. Overlapping groups of elements is common to all tests. This is clearly visible for Na^+ and Cl^- ions, which confirms the presence of a significant amount of sodium chloride on the surface of the analyzed sample.

SEM analysis summary for all performed tests

In addition, for the ASTM test, the Mn peak in corrosion products is visible and it is not the result of the chemical composition of the solution used, but it is derived from the tube material. Same as for the Fe peak, it is an external contamination or comes from the tube material.

Studies have shown that ASTM and DefinX tests present the chemical composition of corrosion products in the way most similar to the spectrum determined for a sample from the market.
