**THE FIBROUS STRUCTURE OF THE BOLT AND ITS EFFECT ON THE JOINT RELIABILITY**

The article presents the cold forging process of flange bolts. Obtaining a compatible, acceptable and incompatible grain flow pattern based of the above mentioned standard was presented. Then the results of FEM simulation were correlated with the performed experiment.

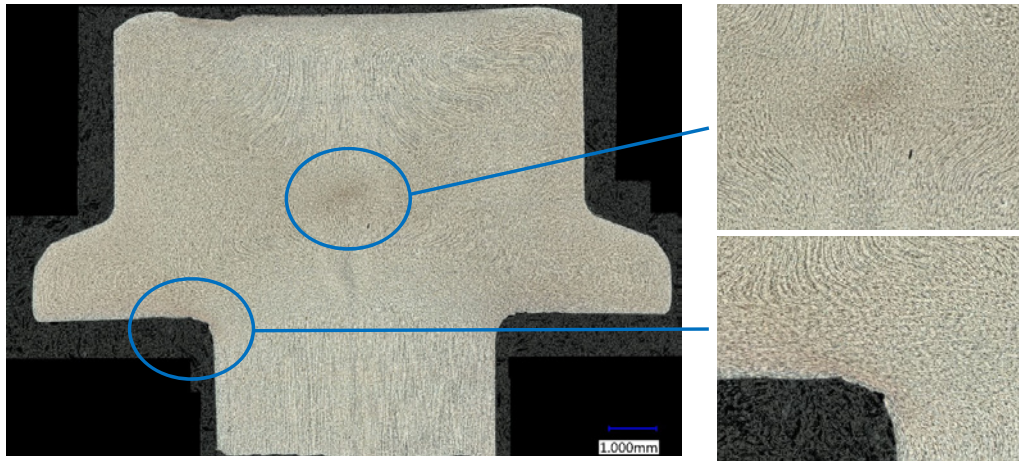
Fig. 1. Macrostructure of cross section of the bolt after cold forging

The listed hazards for high-strength classes are dangerous for the durability of the bolt in long-term use. However, already at the forging stage, there is a major threat to the reliability of the connector, which is an incompatible grain flow pattern. The Ford USCAR 8-4;2019 „Grain Flow Pattern for Bolts, Screws and Studs” standard clearly shows the requirement for the forging process [14]. Directly from the Ford standard there is a transition to surface continuity requirements according to ISO 6157-3 [15]. Forging lap, i.e. lack of surface continuity, is a stress concentrating notch. Incompatible fiber arrangement together with the mentioned threats increases the risk of bolt breakage. The article presents requirements for the grain flow pattern, reference is made to FEM simulation, susceptibility to cracking was verified and bolts were tested in tests of mechanical properties according to ISO 898-1 and ISO 16047 [16,17].

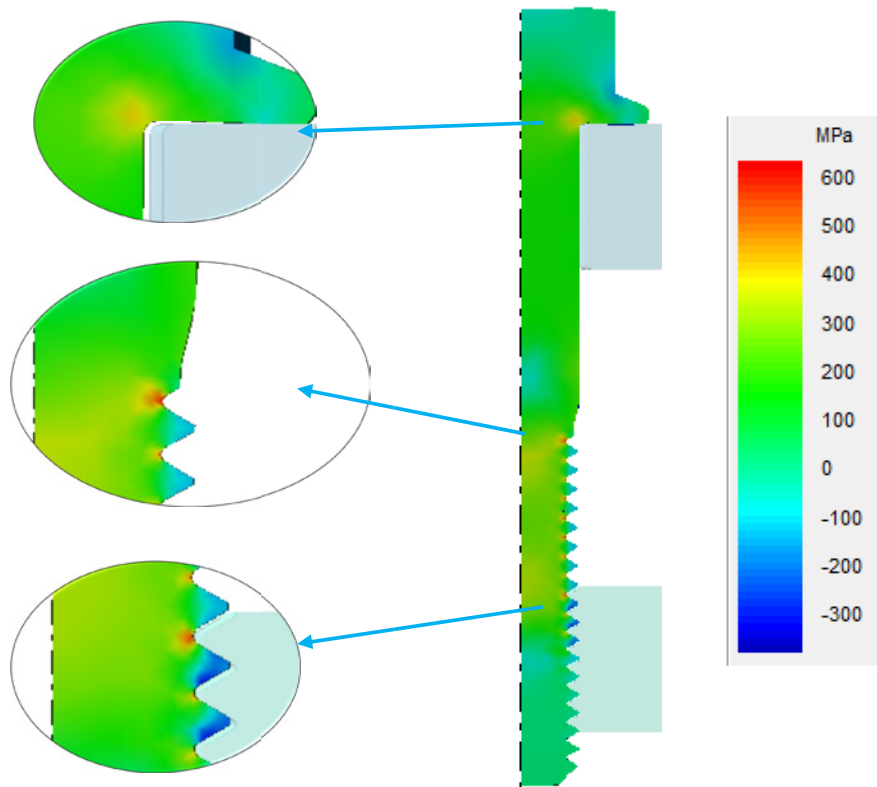
Fig. 2. FEM simulation of equivalent stress distribution in the tensioned bolt

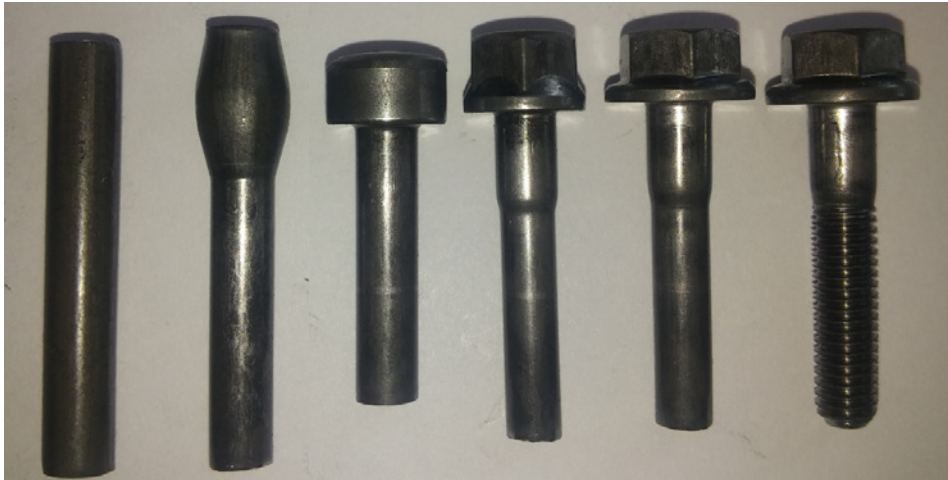
Fig. 3. Wire cut, semi-products and finished bolt with thread

to the diameter of the wire. Their arrangement allows the wire to be straightened horizontally and vertically. The straightened wire goes to the cutting apparatus. The material is cut into equal sections (sticks) by plastic cutting. The correct cut stick has no burrs and the front surface is perpendicular to the axis of the cut. The semi-products (Fig. 3) are fed between operations with the help of paws.

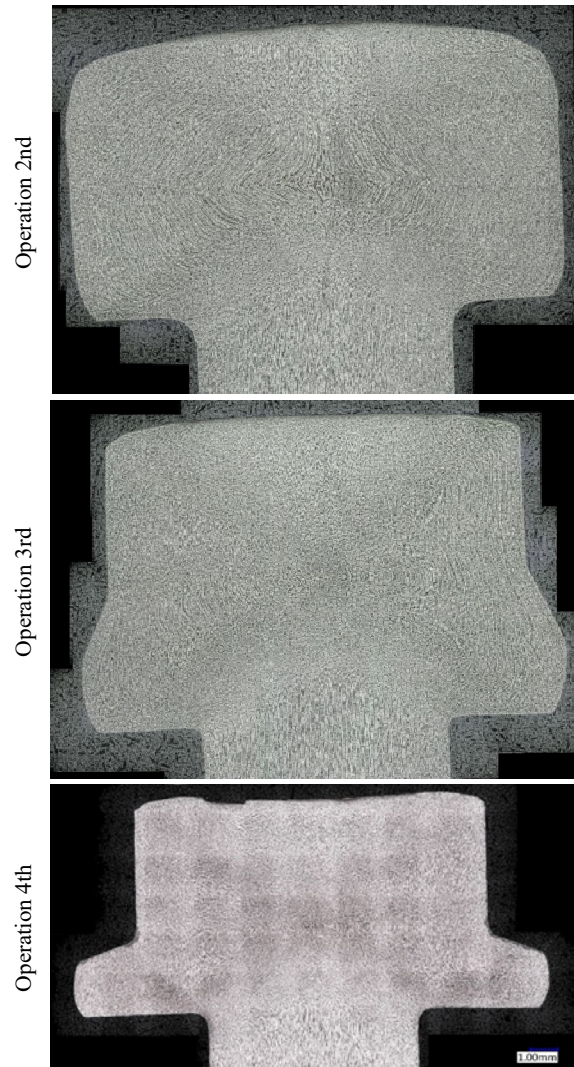
Fig. 4. The metallographic analysis of three forging operations

The metallographic analysis included three forging operations (2, 3 and 4) is shown in the Figure 4.

Material flow lines (Fig. 4) determined in FEM simulation using the QFORM program (Fig. 6) do not fully reflect the results of the experiment. The most discrepancy is in variant 4, where in the FEM simulation there was no forging lap and the flange was not completely filled. The discrepancies may result from the use of 19MnB4 material strengthening curves in the simulation and 30MnB4 in the experiment. The discrepancy between the materials used in the study and the experiment was due to the fact that at the beginning FEM simulation was performed, then the experiment was carried out. Due to production planning and the distant deadline for the production of flange bolts made of 19MnB4 material, it was decided to conduct an experiment on current production from 30MnB4 material. Variant 4 shows a high concentration of material flow lines in the transition radius. In variant 2, the simulation correctly mapped the experiment, the program showed a forging lap on the bearing surface. Variant 1 obtained a consistent result in the simulation and experiment.

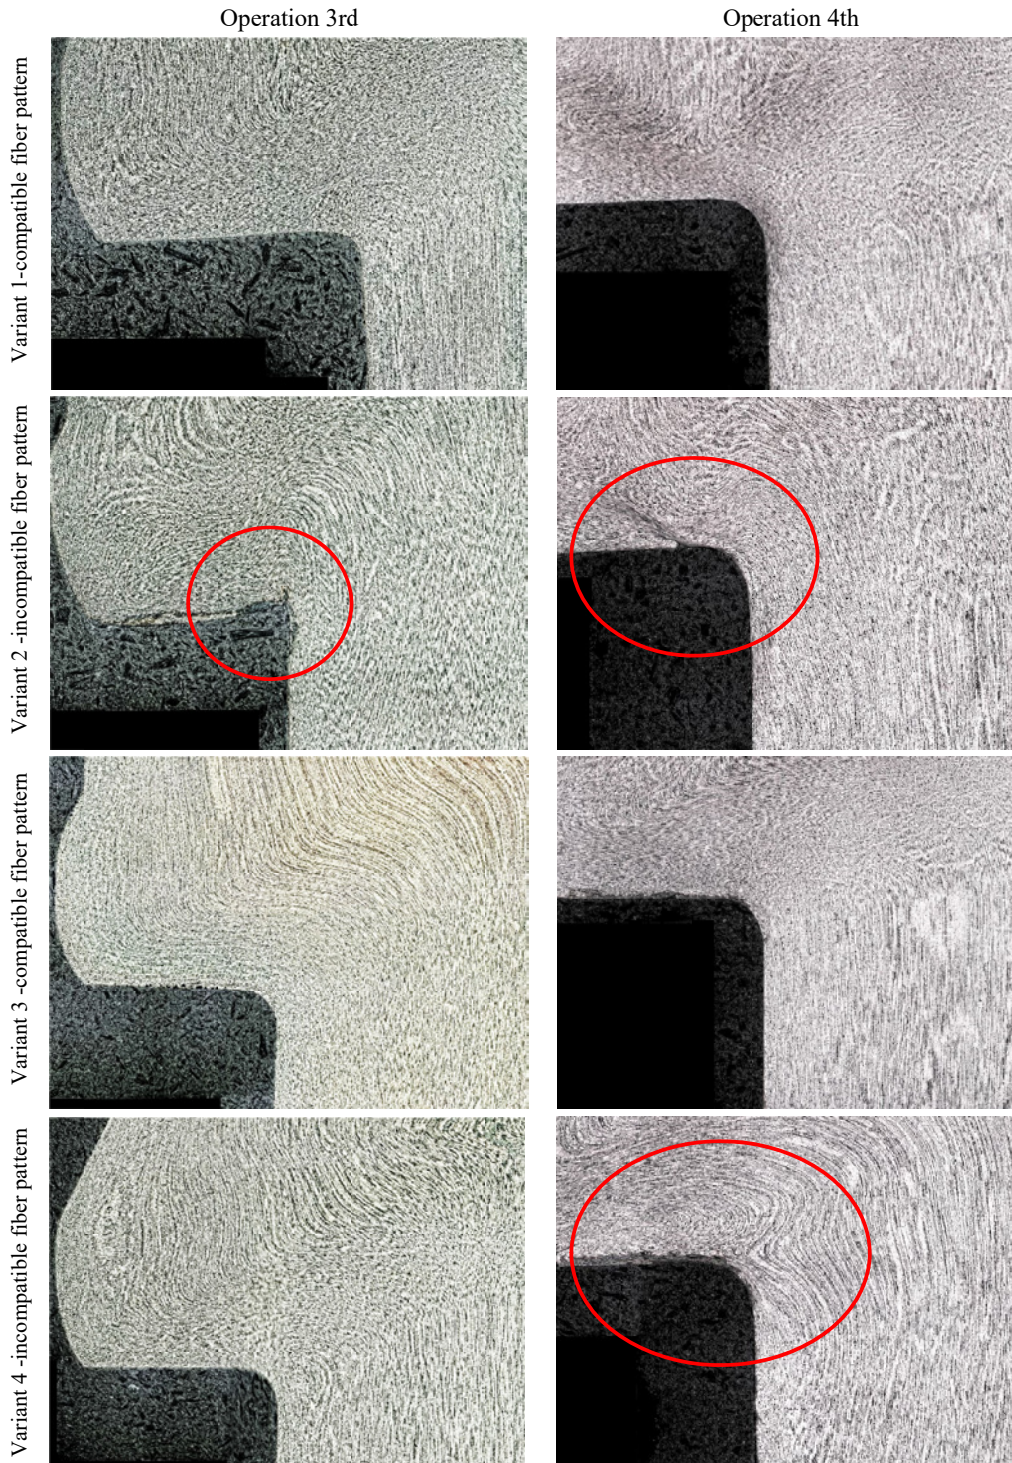
Fig. 5. The metallographic analysis of two forging operations for four variants

The metallographic analysis of two forging operations for four variants is shown in Figure 5. In each variant, the input

**VARIANT 1** has a compatible fiber arrangement. The length of the pin in the first operation is 53,80 mm, while the total length is 70,96 mm. The fibers continuously pass from the mandrel into the bolt head, forming on the transition radius. The microstructure compliance is transferred from operation 3 to operation 4, i.e. the main assumptions of bolt head shaping such as the principle of constant volume of material and the principle of gradation of radius are met.

**VARIANT 2** has an incompatible fiber pattern. The length of the pin in the first operation is 52,86 mm, while the total length is 69,94 mm. It results from excessive bolt support in 3 operations, where the fibers shifted from the height of the abutment surface to the height of the flange profile. The fibers were cut at the transition radius to form a forging lap. In operation 4, the material shifted to the bearing surface, and the fibers cut across the transition radius.

**VARIANT 3** has an acceptable fiber arrangement, however, discontinuities will disqualify the product. The length of the pin in the first operation is 54,96 mm, while the total length is 72,1 mm. In operation 3, the flow of material and the shape of the blank is similar to operation 3 in option 1. In operation 4, the material was pushed from the head into the bolt. This was due to the ejector support lower by 1 mm compared to variant 1, so when shaping the bolt head some of the material went into the bolt.

**VARIANT 4** has an incompatible fiber pattern. The support was set 2 mm lower than in option 1. The length of the pin in the first operation is 55,84, mm, while the total length is 73,03 mm. In the first forging operation, material allowance was placed on the bolt head so as to obtain head filling in operation 4. In operation 3, the fibers are rounded over the transition radius. In the forging operation 4, the pressed material led to fiber break in the transition radius. In addition, a forging lap occurred on the bearing surface under the head.

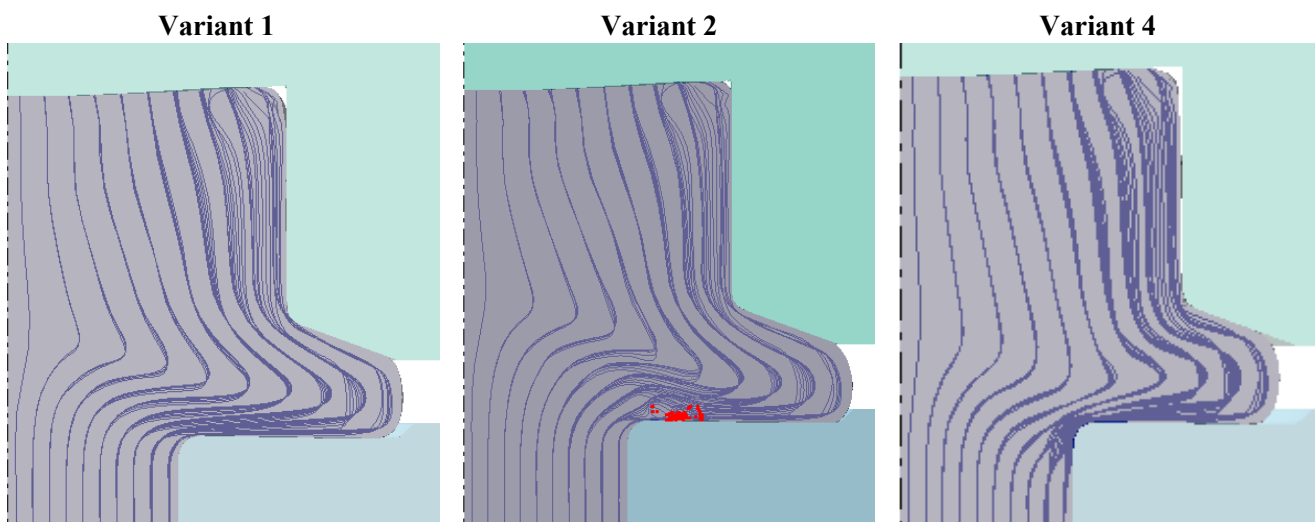
Fig. 6. The FEM analysis of fourth forging operation for three variants

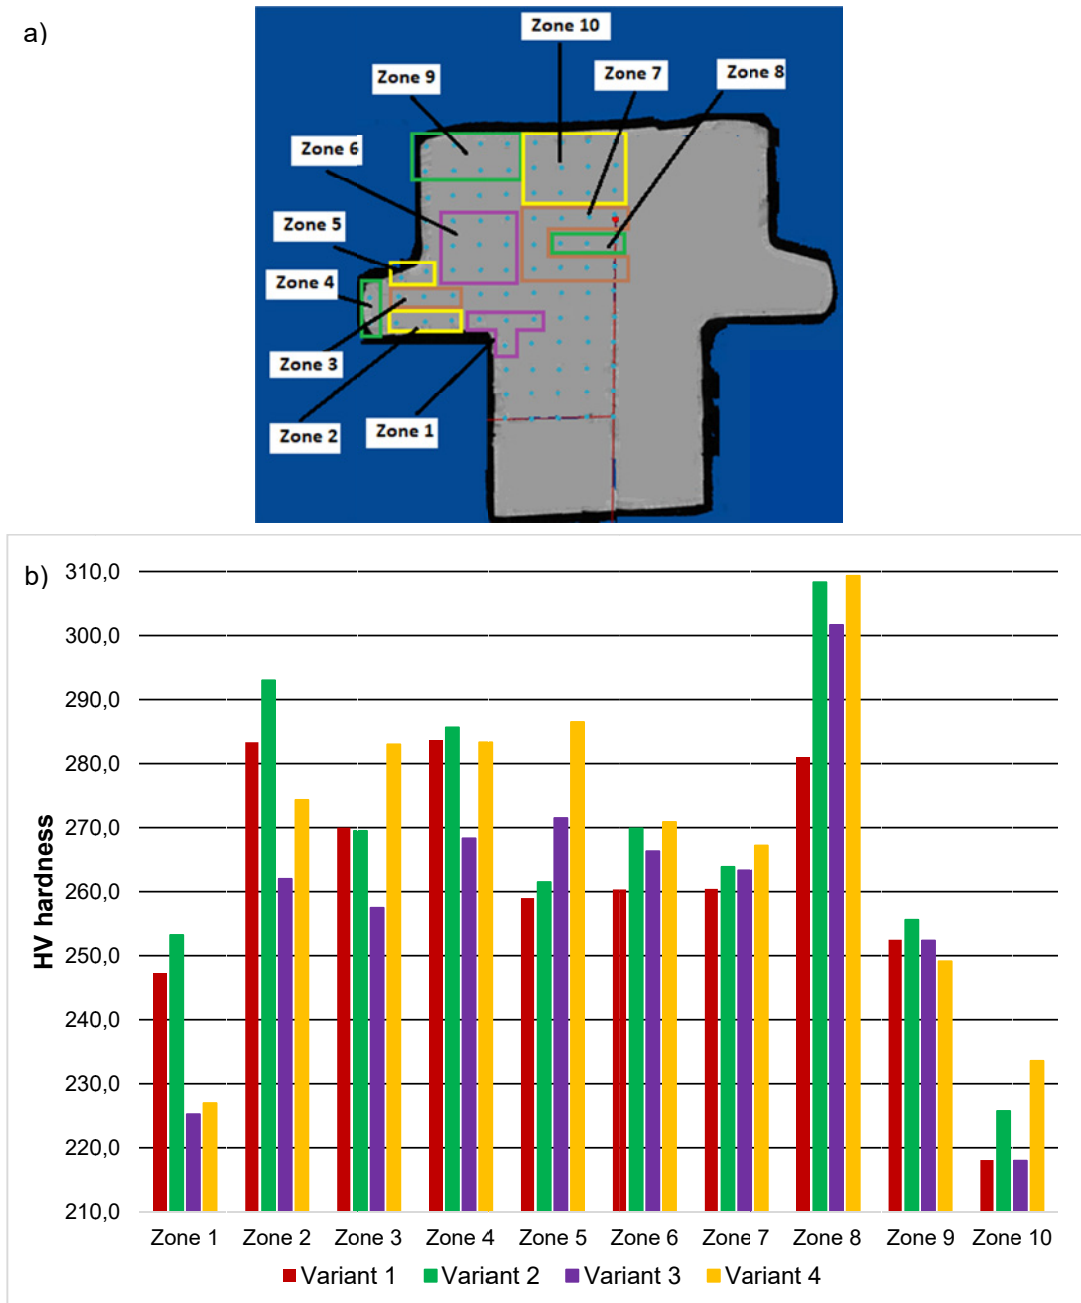
Fig. 7. a) The pattern of hardness measurements places in cross section of bolt head, b) Results of hardness measurements in particular bolt zones

The average hardness value of the mandrel, i.e. in a zone with low deformation, was 204 HV. The area of the bearing surface on the flange concentrates higher stresses in Option 2 equal to 293 HV, whereas as a result of high support material moves from the bolt pin into the flange. In turn, on the periphery of the flange, the highest hardness values of 283HV were tested in option 4, which results from the largest head volume allowance before operation 4. Inside the head, the lowest hardness values characterize the prepared variant 1, where in hardest zone 8 hardness 288 HV was obtained, and in zones 6 and 7 after 260 HV. In

variants 2, 3 and 4, the hardness is 328 HV, 309 HV and 313 HV in zone 8 respectively. At the head surface, the most favorable hardness distribution is in options 1 and 3, and the tools will be most heavily loaded in options 2 and 4.

The hardness distribution showed that the correct fiber arrangement generates much lower stress values in areas close to the sample axis. In turn, in the area of the bolt flange, Variant 1 is no longer as optimal for the tools used there. It should be borne in mind, however, that the basic criterion for developing the technology is to ensure the reliability of the bolt, i.e. to achieve a compatible grain flow pattern and surface continuity. In the third place should you put the tool life resulting from the developed technology. The technologist's task is to find a compromise that meets these and other criteria for designing the forging process.

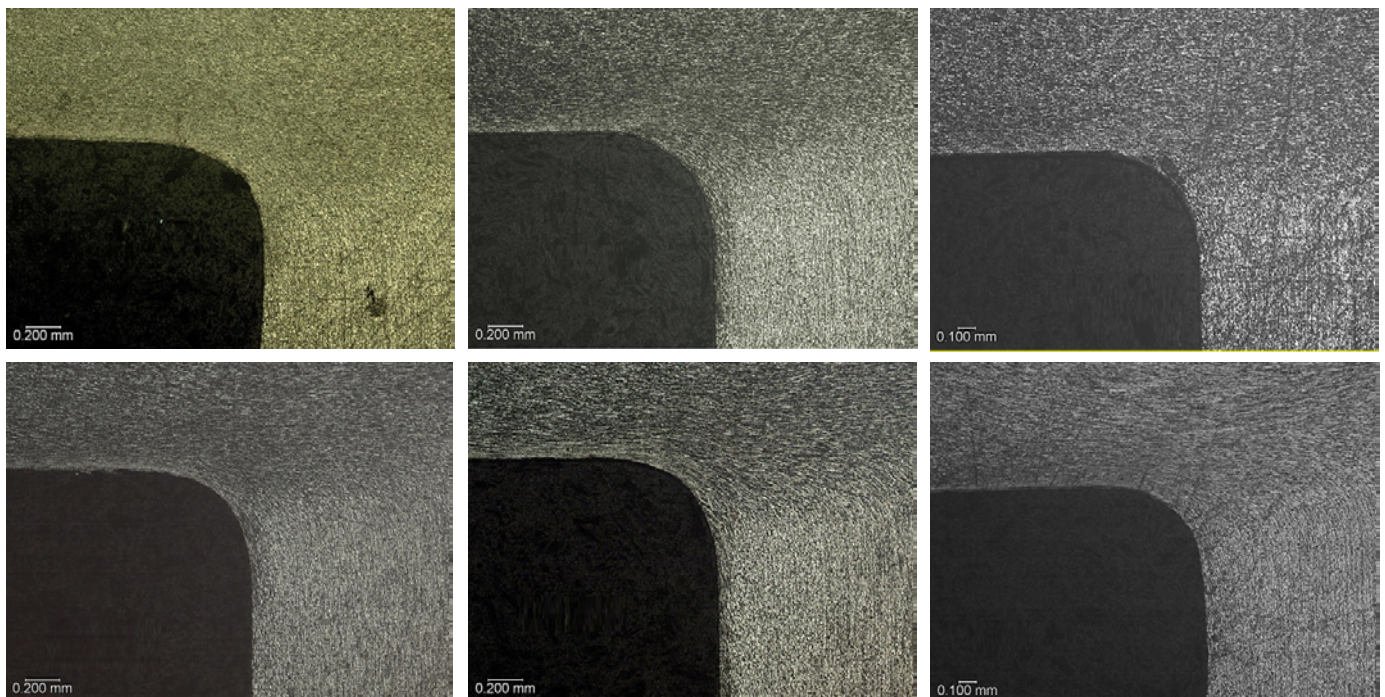
Fig. 8. Grain flow pattern tests on a new batch of bolts with each new resumption of production

In the case of responsible fasteners in cars or machines, where human health and life depends on their reliability, fiber system testing is performed for each production batch. This solution is part of the methods of continuous improvement, the emergence of requirements for the correctness of grain flow pattern was the driving force for organizing the appropriate procedures. Orientation on organizational culture, i.e. the consolidation of the forge operator's habit that the key aspects of the bolt that affect quality and safety should be checked have facilitated the minimization of bad batches. It is the employee of the forging department who gives an impulse in the form of providing samples before approving production to laboratories. To optimize real forging times, these tests are performed first, so the operator doesn't have to wait long for the forging to start. In addition, USCAR – 8 testing is required by an IT system and production cannot be started without the approval of a laboratory employee. System confirmation of product quality gives 100% certainty that the bolts have been checked. The quality control process is maintained, i.e. the contact of the production employee with the laboratory team. The applied solution is also part of quality assurance through good production the first time and usefulness of use. An example is a product whose production is renewed every month (Fig. 8). Pictures shown in Figure 8 were taken from January to June 2019, where each picture corresponds to the production batch from the next month. As can be seen in the Fig, the accepted fiber arrangement was consistent in each month. The introduced system confirms the high quality of manufactured products and minimizes the risk of breaking the connectors during operation.

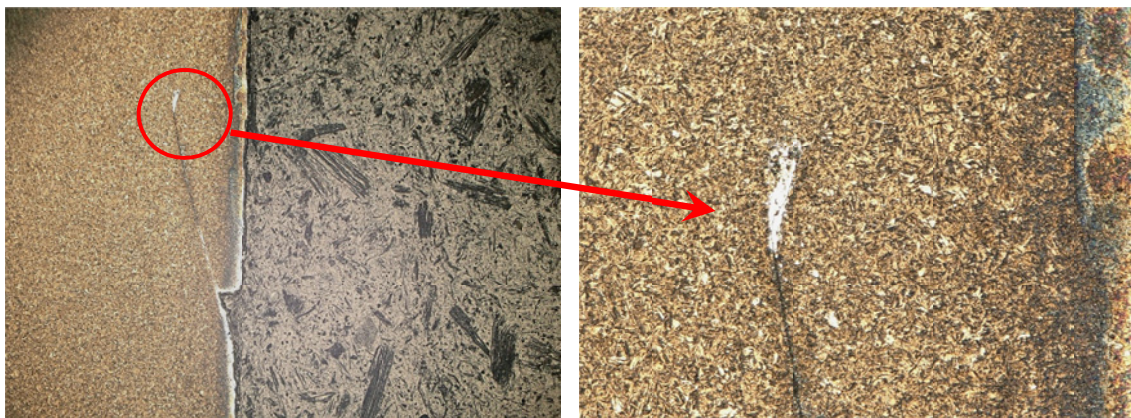
Fig. 9. Forging lap with ferrite  $\delta$  layer on the bearing surface of the bolt

The tested bolts did not break brittle. However, a negative phenomenon can be observed, which was revealed in the assessment of microstructures. Based on literature sources the research carried out so far in the field of the impact of the zinc phosphate coating on the surface of bolts in heat treatment processes, the occurrence of the delta ferrite phase on the tested samples was defined [10,11]. The ferrite  $\delta$  layer occurred not only on the surface of the product but was also trapped on the tip of the forging lap in bolt (Fig. 9). Zinc phosphate was localized in the forging lap already during the forging process. In this situation, after washing and removing phosphates, it will remain in this defect and lead to the formation of ferrite  $\delta$ .

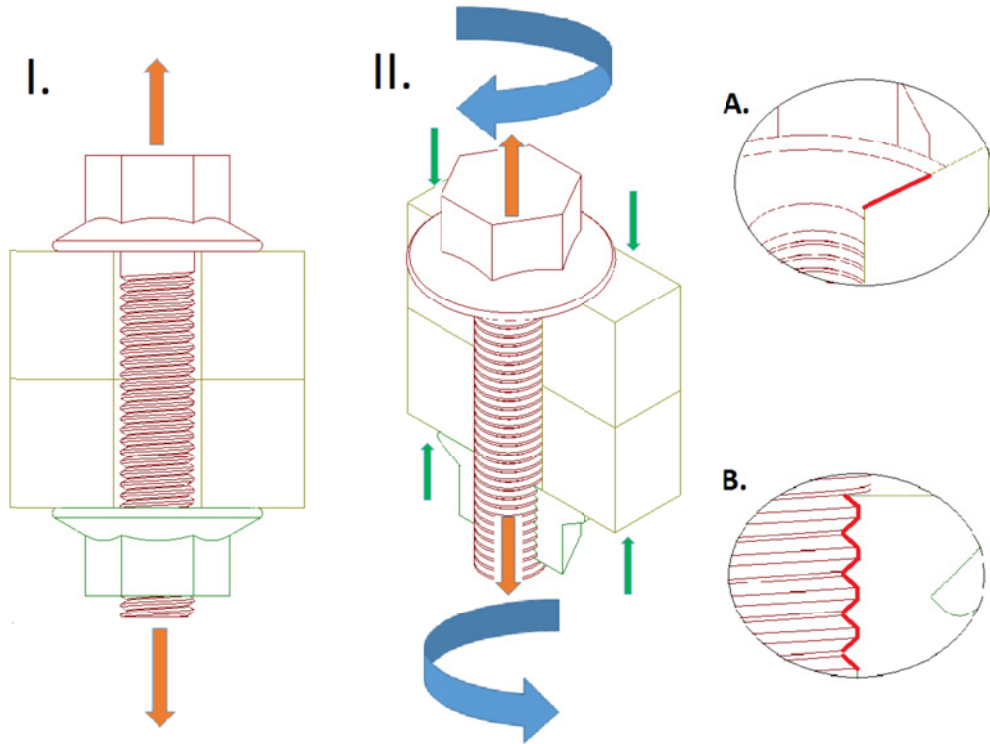
Fig. 10. I – static tensile test and simple system of forces. II – bolt assembly and complex system of forces

The yield strength obtained in the assembly test is lower than that determined in the static tensile test. The difference results from the systems of forces occurring in the connection during the test. There is a complex system of forces in the tightening test. An important role for the results is played by the coefficient of friction on the thread and under the bolt head, creating the total friction coefficient. A change in its value will be responsible for a change in the clamping force obtained in relation to the torque. An increase in the coefficient of friction will cause a decrease in clamping force and an increase in torque, because more energy is used to overcome frictional resistance.
